Ivory Lake Hut Maintenance and Repair.

April 2016.

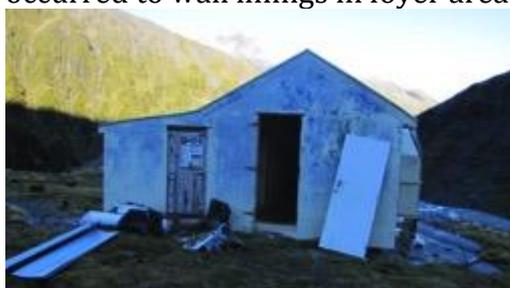
Coordination with other backcountry users and Andersons Helicopters enabled Keith Riley and Martyn Bisdee a brief time window to replace a missing front door and to assess hut condition prior to the onset of winter. Some damage has occurred to wall linings in foyer area.

Figure 1 Missing front door replaced with temporary door.

Urgent works. Door replaced.

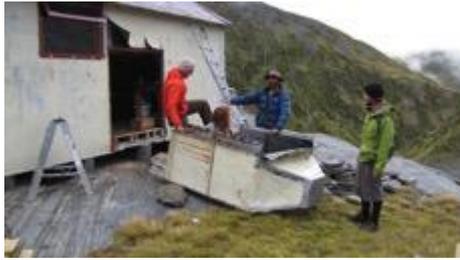
This structure was a metal box constructed of sheet metal and angle iron bolted to the side of the hut. Its upper surface had a sealed flue outlet (like a chimney) and sheet metal sloping back towards the hut. There were numerous visible historical attempts to waterproof this attachment.

After careful consideration, it was decided that the structure would need to be completely rebuilt at significant cost and man-hours. We believed there were far more pressing issues than building an extra 'micro wing' onto the hut.

Figure 2 Removal of cooking alcove.

The structure was flat packed and flown out.

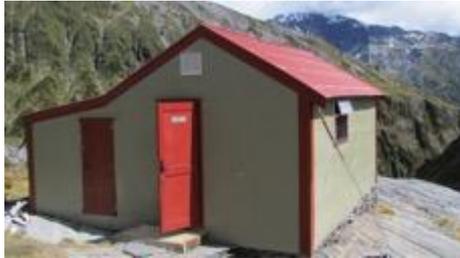
Figure 3 Repaired North wall.

The remaining cavity was rebuilt as a straight wall matching existing structure inside and out. Insulated and clad with sheet metal as per existing hut.

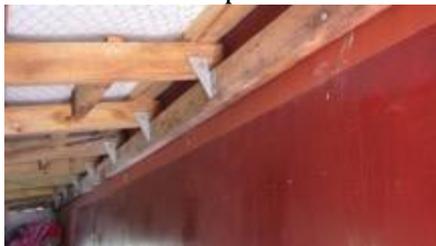
Upon closer inspection, it was discovered that the lean that had historically functioned as a workshop had suffered snow load damage including cracked or bending rafters and failing stringer connections to the main hut. Decayed roofing paper and rotten rimu purlins Added to the woes of this area.

Figure 4 Lean to structure and connection to main hut.

The stringer was jacked back into level and raised by 70 mm enabling the roof line to reconnect with the main hut roof at its top plate. The stringer was fixed with 100mm bugle screws. Coach screws will be added at next working bee. Roof was removed, purlins replaced, z nails attached where possible. New building paper added.

An extra row of purlins added to strengthen structure.

A small soffit and barge board has been added to the lean to in hope of reducing wind blown moisture and to reduce the snow stress on the over hanging roofing iron at its end. See figure 4.

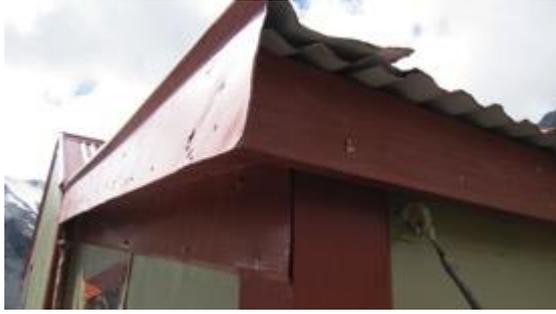
Figure 5 Extended roofline and new bargeboards/ soffits on southwest corner

The roof was extended 150 mm on the west wall enabling it to finish inline with the main hut roofline. This hopefully provides improved water tightness at a small internal corner at the lean too/ main hut junction, west wall.

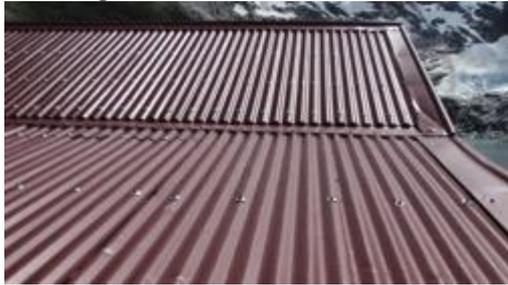
Figure 6 Cyclone washers and change of pitch flashing.

A new change of pitch flashing was added between junction of main hut roof and lean to roof.

Roofing iron was reattached with 70 mm roofing screws and cyclone washers.

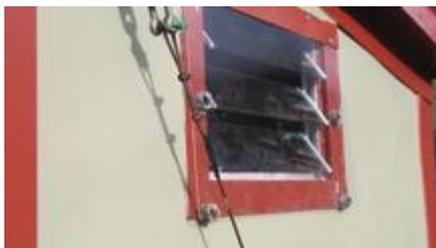
Figure 7 Reinforced windows

Both windows of the hut were reinforced with Perspex.

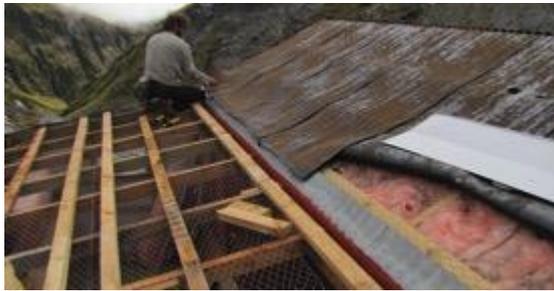
Removal of this roof indicated both building paper and insulation in good condition. Moisture damage may have been caused by existing building paper being tucked inside the external cladding, rather than over. This was remedied on the south pitch by cutting and repositioning, plus adding new building paper. Both roofs were primed and 2 coats of 'pioneer red' Dulux paint applied. All nails replaced with 70 mm roofing screws and cyclone washers.

Figure 8 Roof cavity revealing good batts and building paper.

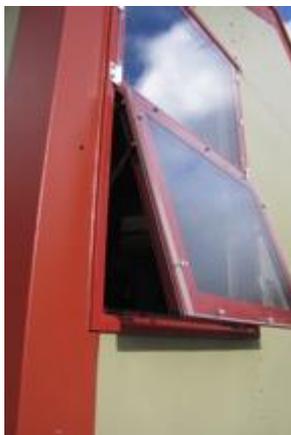
The removal of both windows indicated they were a likely source of moisture into the hut.

Figure 9 West window with Perspex protection.

Both windows were replaced with new double glazed units. Both had 10mm Perspex attached 5-10 mm in front of the glass. This is to protect against windblown stones at the previous windows had suffered from.

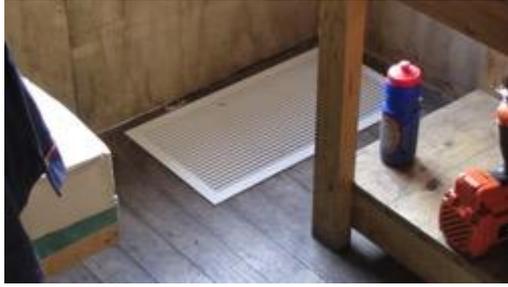
Figure 10 Floor ventilation. See fig 12 for wall vent.

Floor and wall vents have been installed to create ventilation across the hut. Floor vent in the west end of the hut. Wall vent at the east and the apex of the roof.

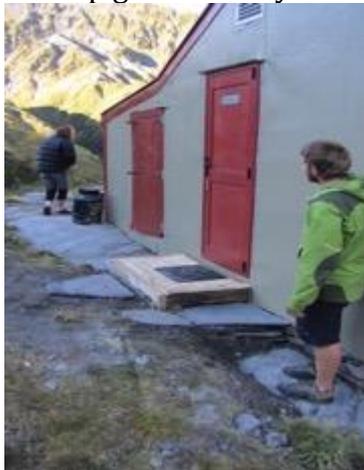
Gravels and vegetation on the East wall were higher than the bottom of the hut this was dug back to bedrock. Vegetation replanted and stonewalls established to keep gravels away from hut.

Figure 11 New landing and drainage on East side. Wall vent is visible at top of hut.

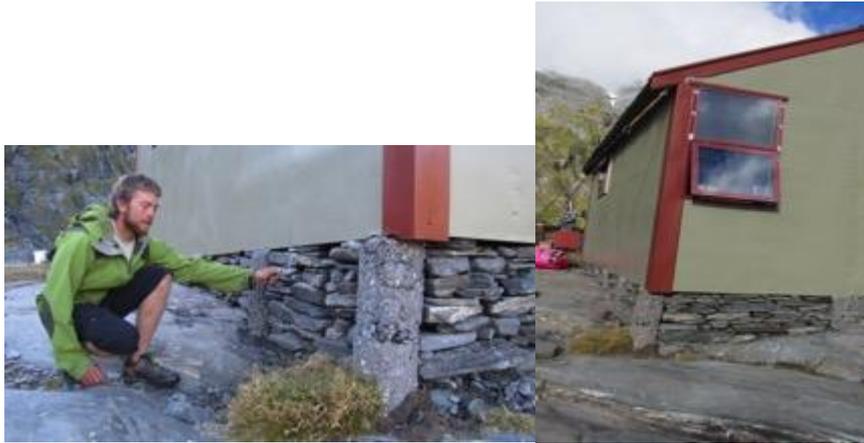
Figure 12 Stone works to reduce sub floor airflow.

To reduce airflow under the hut, stonewalls were build between external piles.

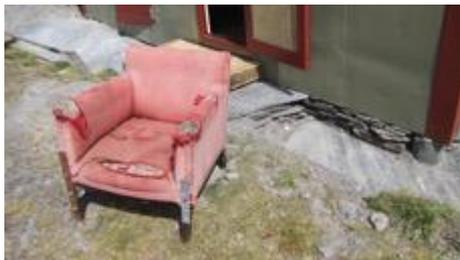
Figure 13 The chair of recession ready for another decade.

The inside of the hut was cleaned out, chairs and tables repaired, surplus kitchen paraphernalia, historical food and mildewy paper removed.
