**New Zealand
Outdoor Recreation
CONSORTIUM**

“A partnership to maintain and enhance backcountry facilities”

Top Trent (Lagoon) Hut

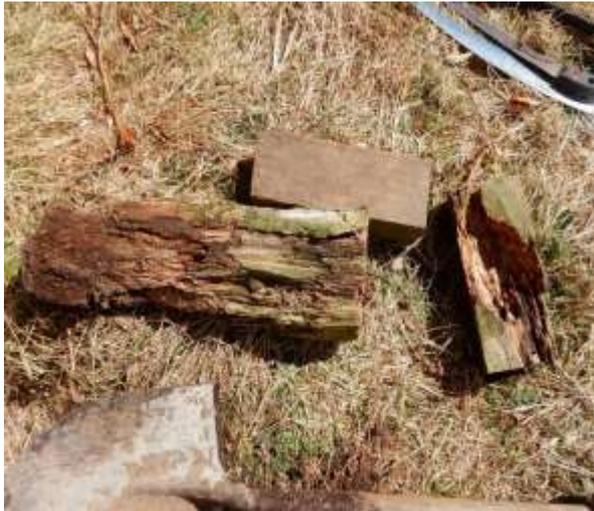
Above: Not so good piles

The working party replaced three piles, including a pile that was effectively doing absolutely nothing to support the hut as the bearer above it was non-existent. It gives new meaning to a 'dozy' pile. The 3 piles were replaced with 125 x 125mm H5 treated piles & concreted into place. The 'absent' section of bearer was replaced & braced.

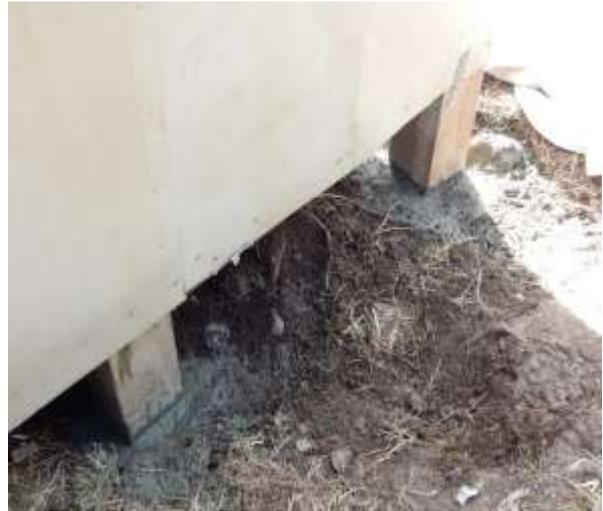
Above: Much better & solid looking

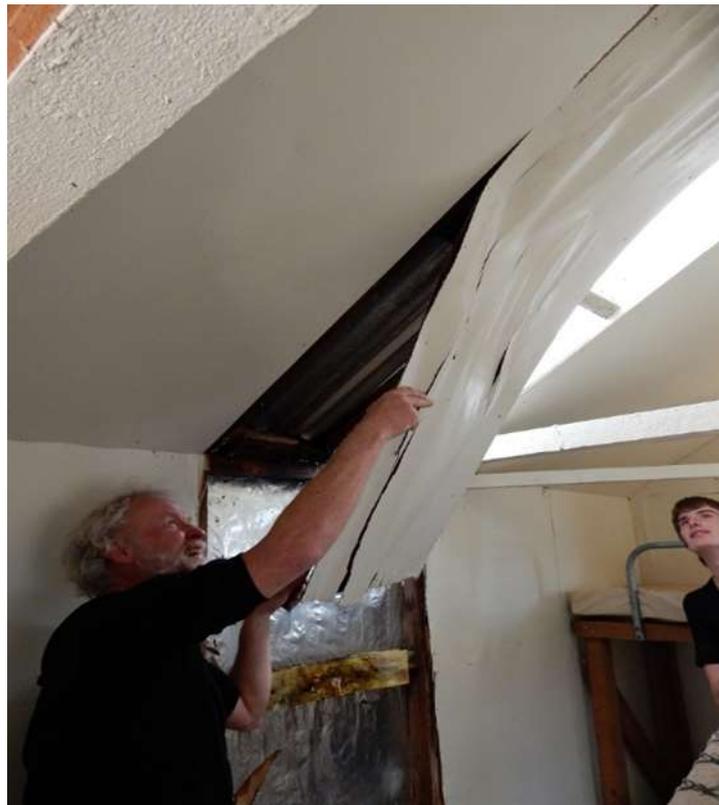
The ceiling ply panels on the south side of the hut close to the skylight were removed but what would we find hidden underneath.

Above: Kevin Bolitho & Kerry Clapham about to find out what lies beneath

It was not a pretty sight with yet more rot, so 2 new rafters, a centre board, top plate, top plate support & 2 purlins were installed, along with a support brace for one rafter.

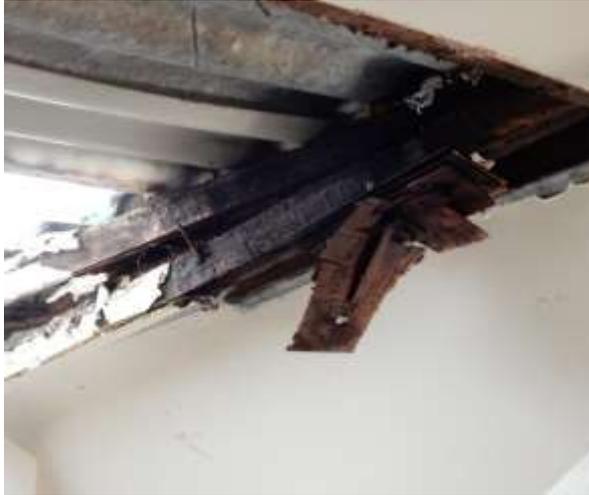
Above: Rot in the ridge board

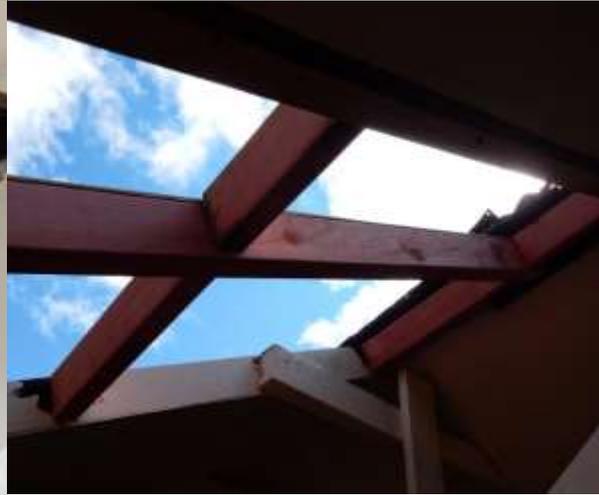
Above: New ridge board, rafter & purlins

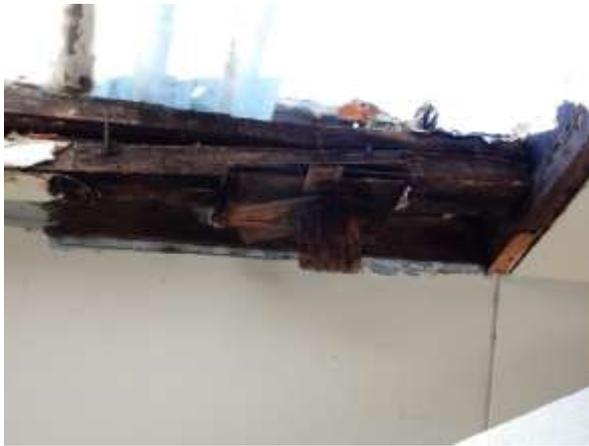
Above: Rot in the sky light top plate

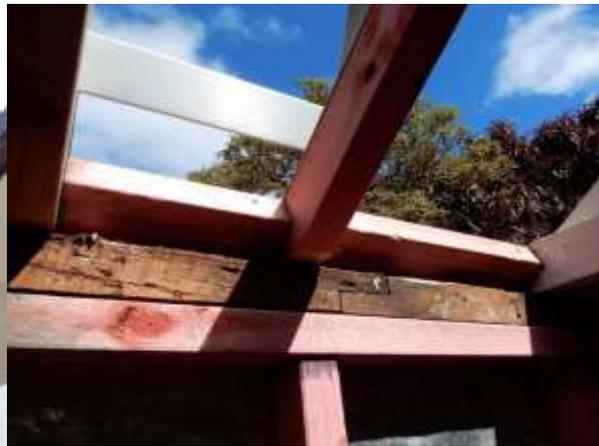
Above: New top plate support & rafter

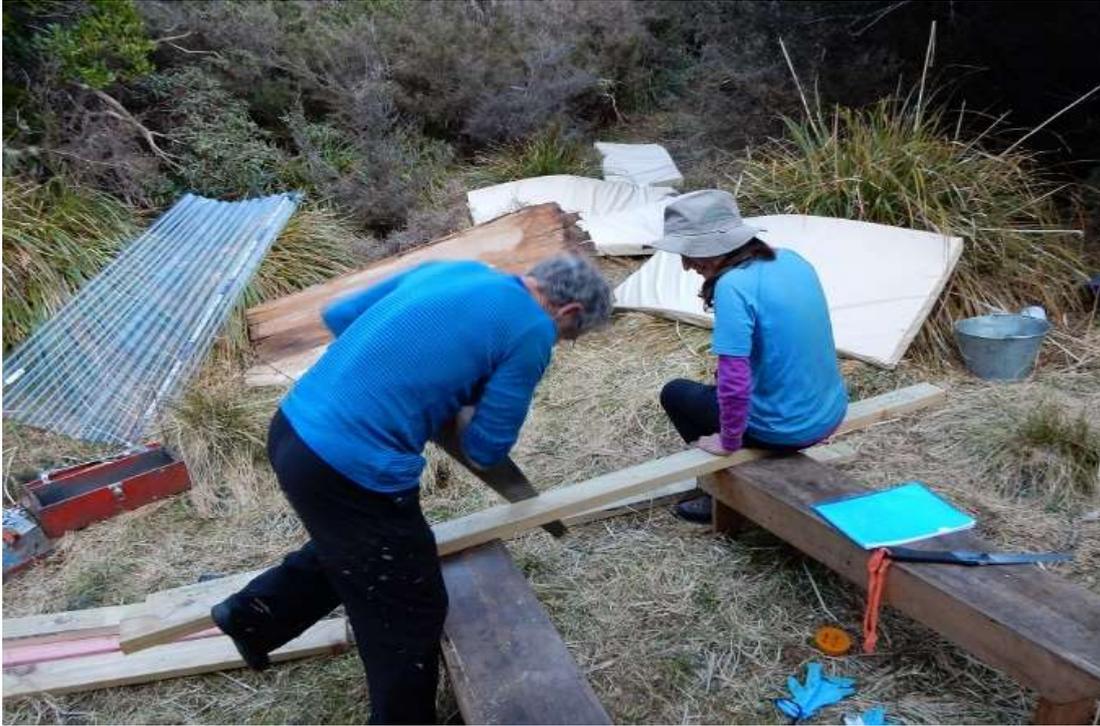
Above: Geoff Spearpoint & Emma Richardson prepping a roof rafter

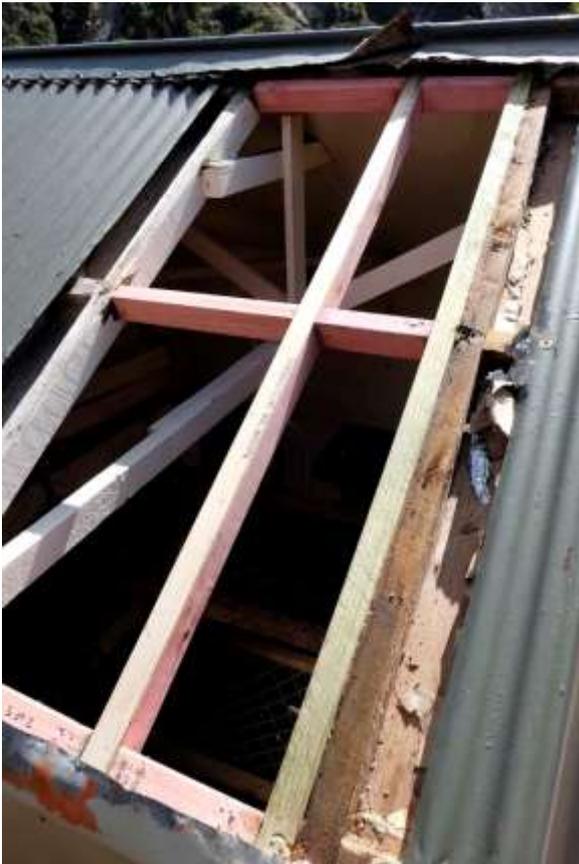
Above: The new sky light framing in place

At the same time as the internal ceiling ply was being removed the brittle skylight on the south side of the hut was replaced with a new piece of Suntuf clear polycarbonate corrugated roofing. A piece of PVU type clear plastic sheeting was installed beneath the Suntuf to prevent condensation on the corrugated roofing from dripping into the hut. A wide strip of 'flashtack' folded back on itself was used to replace much of the ripped & broken lead flashing.

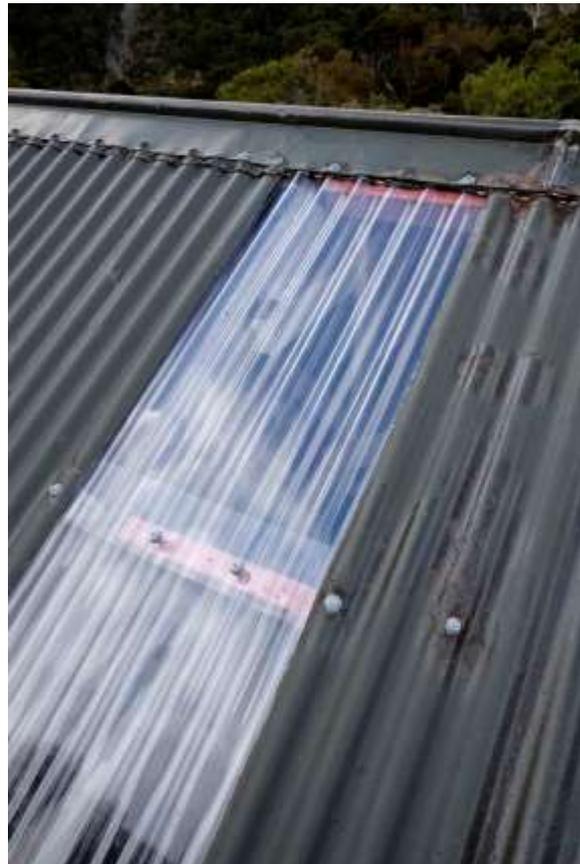
Above: The new sky light secured into position

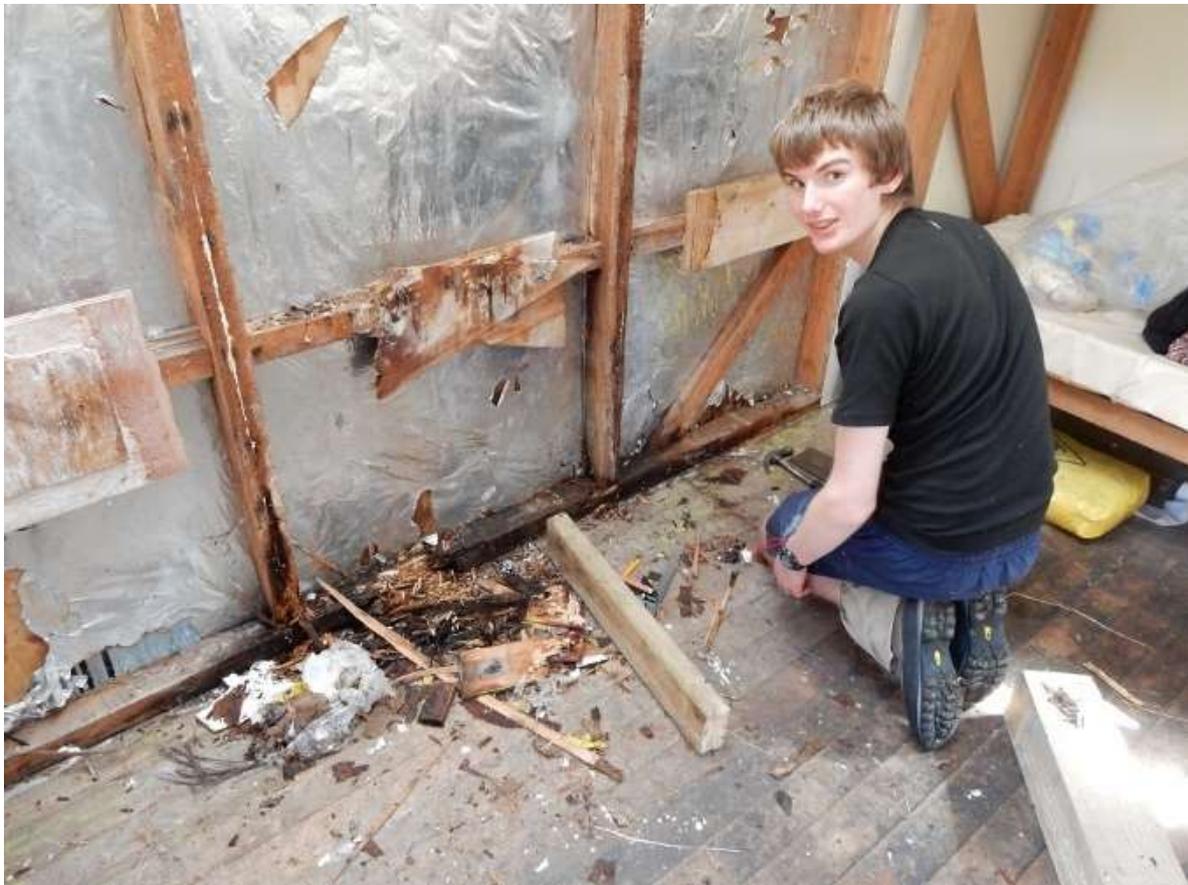
The south wall of the hut received an extensive 'make-over' with replacement of large sections due to extensive water damage & significant amounts of rot. Sections of both the top & bottom plates, 4 dwangs, 2.5 studs, the wall-ends of 4 joists & some T & G flooring were cut out & completely replaced & in some cases double-braced in order to provide additional strength.

Above: Kerry Clapham discovering the full extent of the rot in the south wall

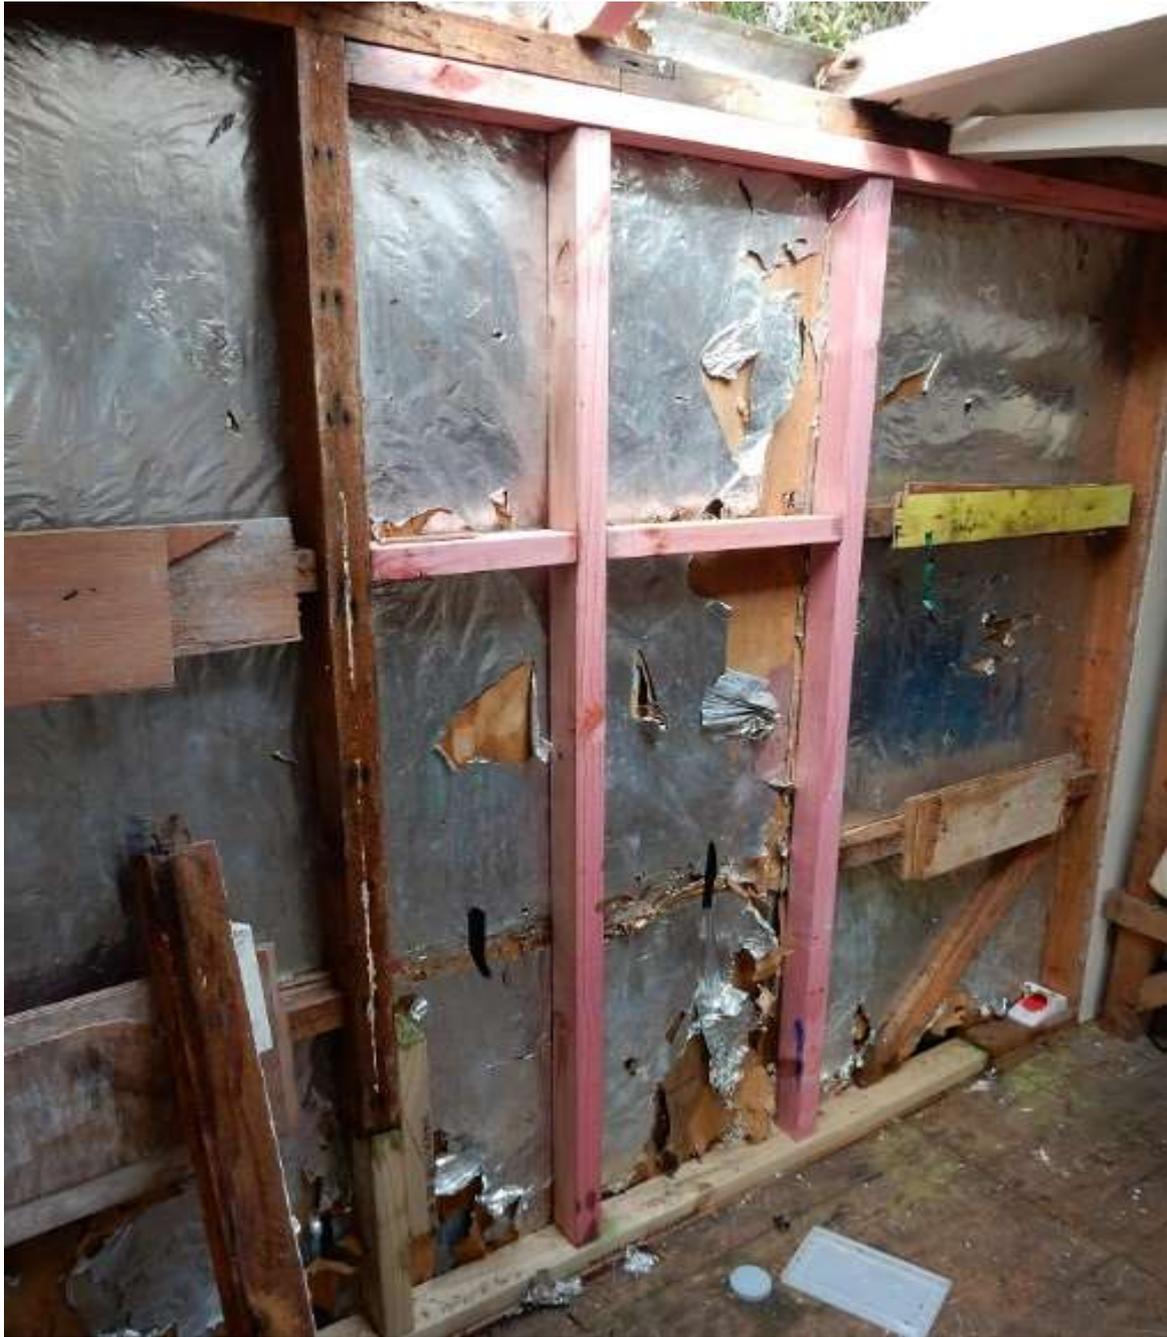
Above: In with the new bottom & top plates, studs & 2 of the 4 dwangs

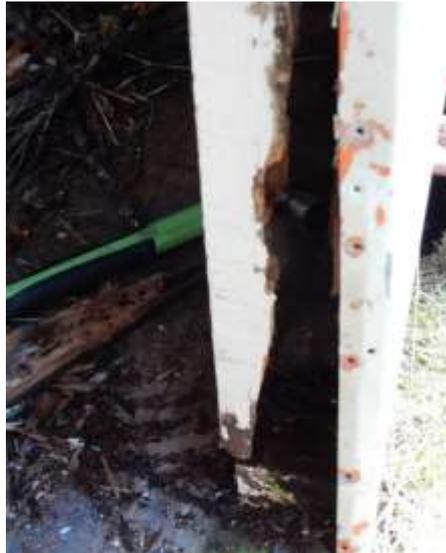
The eastern door stud was completely rotten & the door no longer closed fully as the door jamb had swollen in places. The bottom plate by the door had rotted out. The door stud & bottom plate were replaced & a new door jamb was installed. The external door bolt was loose & moved freely in the door as the original lead-head nails had rusted so these were replaced with hex-head screws.

Above: Rotten door stud

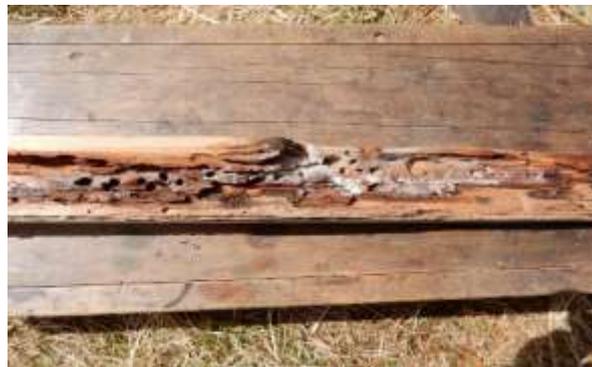
Above: The extent of rot in the door stud was astonishing

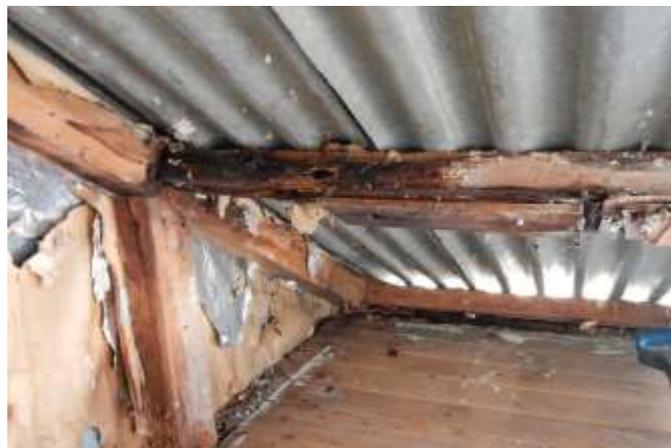
Another section of ceiling ply in the south eastern corner of the hut was delaminated & bubbling, hence this was removed too, only to reveal ... more rot. The centre purlin & a section of the outside wall rafter was well beyond being useful so a new purlin & rafter brace were put together & then put into place.

Above: The rotten purlin. Note the rusted nail not attached to any timber

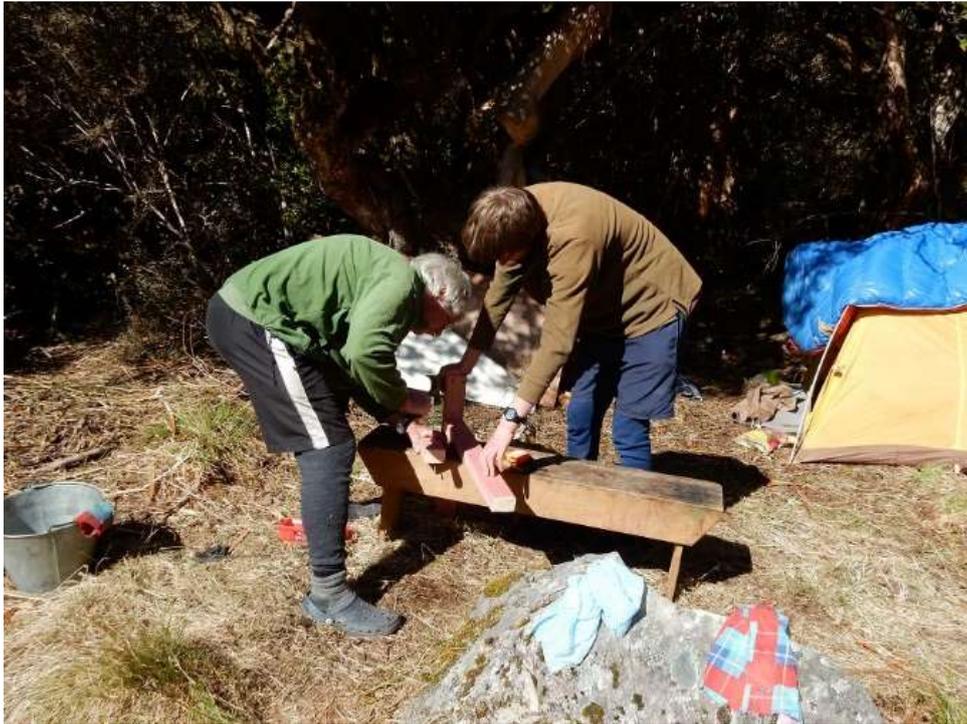
Above: Martin & Kerry Clapham designing a combined purlin & rafter brace replacement

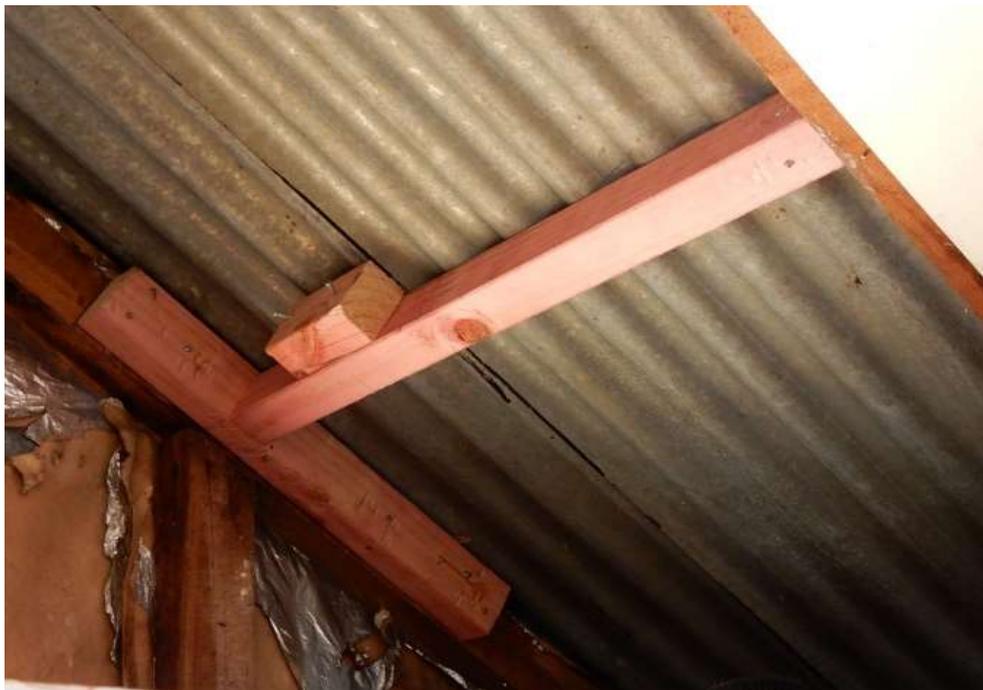
Above: The combined purlin & rafter brace in position. Note the extra block where the old lead-head nail came through the roof

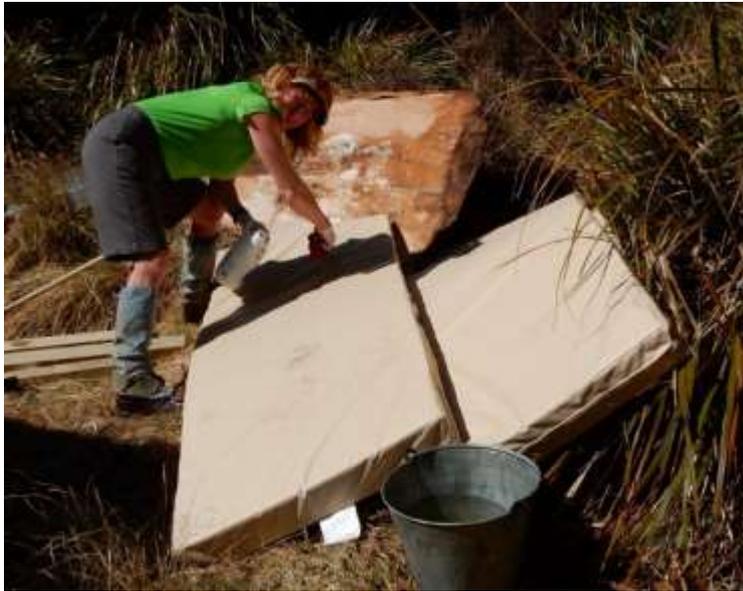
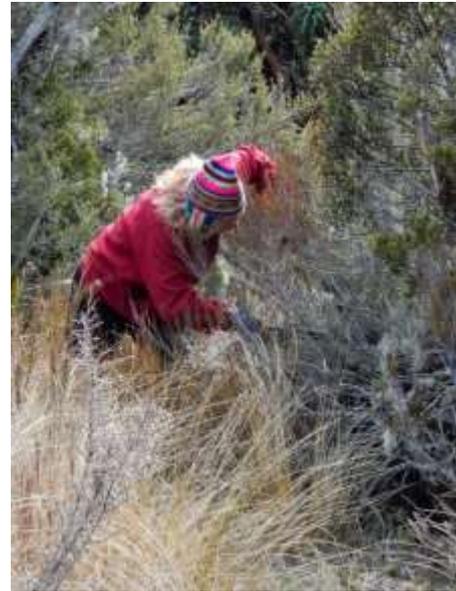
Above: Neroli Aymes applying a bit of elbow grease to the mattresses & trimming away vegetation

Liberal amounts of Metalex was applied to sawn & cut wood surfaces prior to being put into place. The hut mattresses were thoroughly scrubbed clean with bleach & a metal flashing was placed over the end of the new bearer & pile. Sections of the flat iron walls where nails had rusted & or become loose were re-secured with a combination of square head screws & liberal amounts of sealant or hex-head screws with washers. The hut roof was spot sprayed with a rust killing product. The tracks

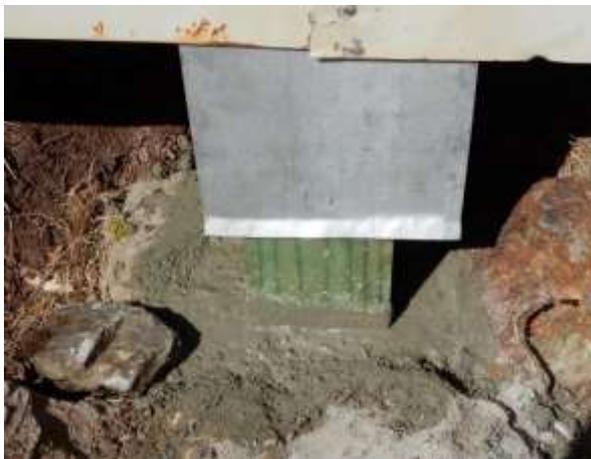
Above: New flashing to protect the new bearer & top of pile

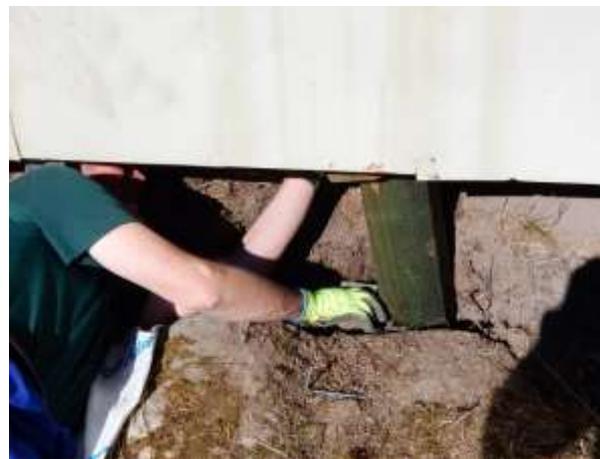
Above: The camera shy Alan Jemison tackles another pile

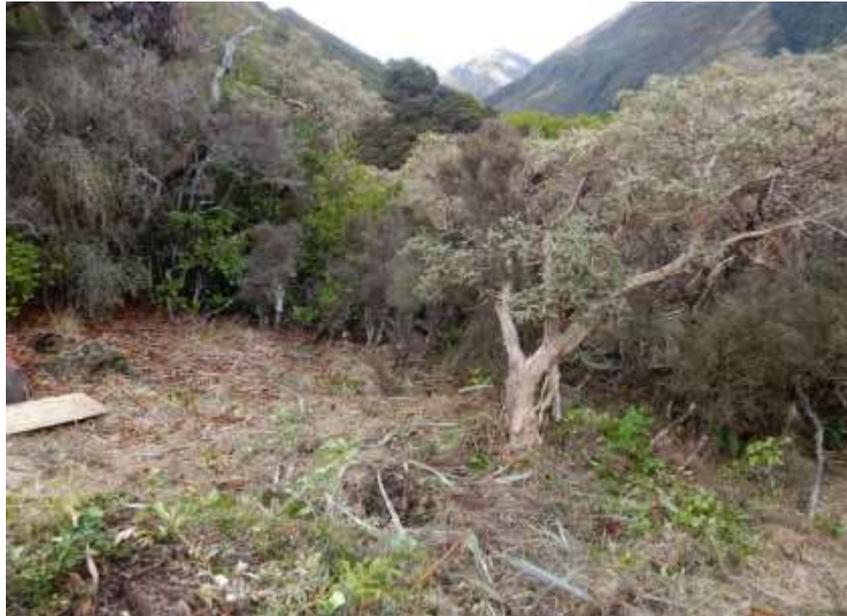
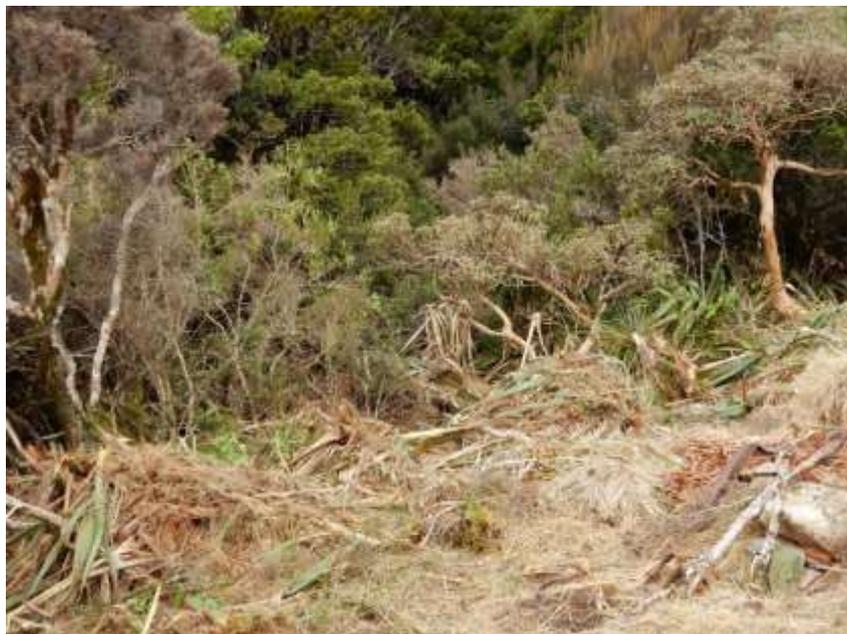
Above: Low level scrub cleared away from around the hut clearing
