THOMAS RIVER HUT REPORT

For DOC, the Consortium, and Permolat.

Geoff Spearpoint update 23.11.16

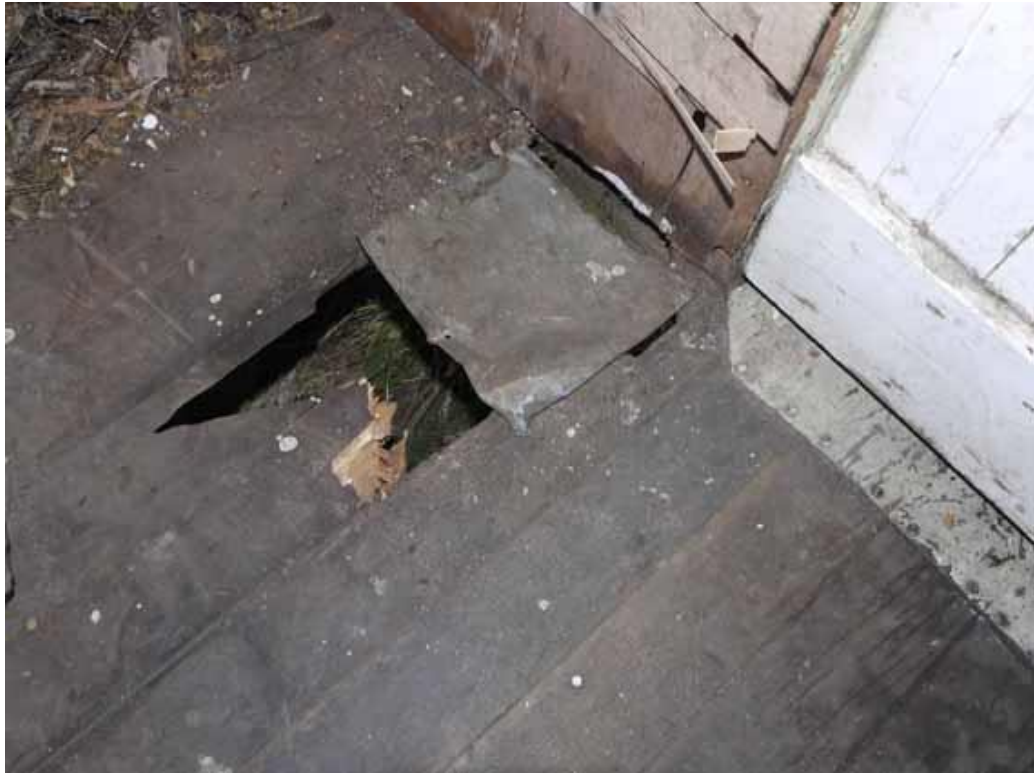
Broken and rotten floorboards by the door, 2015.

Sven Brabyn and I crossed over the Thomas Range and descended to Thomas River Hut. Sven scrubbed down the mattresses which were in a very filthy mouldy state. I replaced 4 broken/rotten floor boards near the door. We did some track work with loppers and surveyors tape down the valley to the Haast.

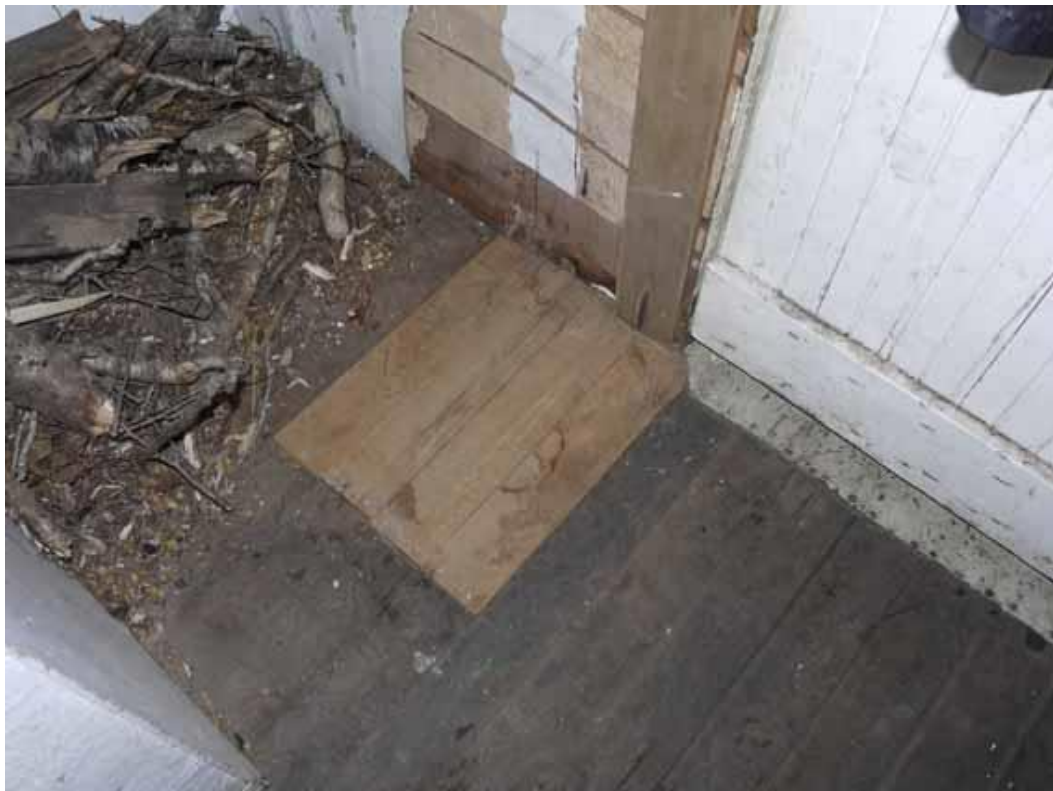
Floorboards fixed, 2015.

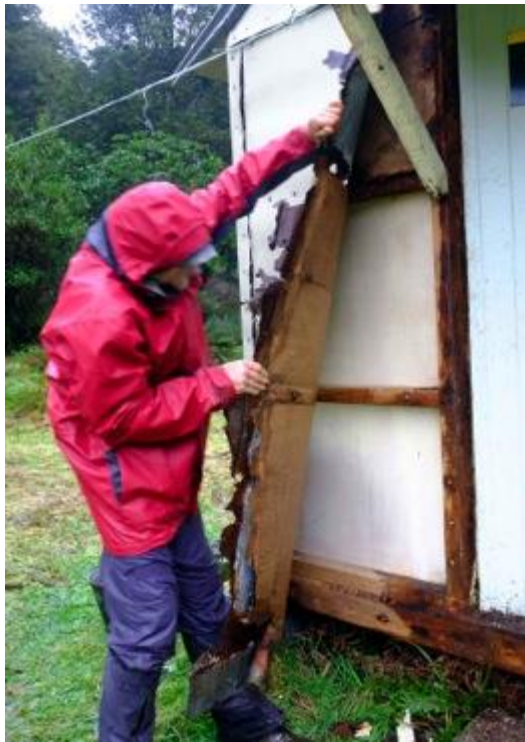
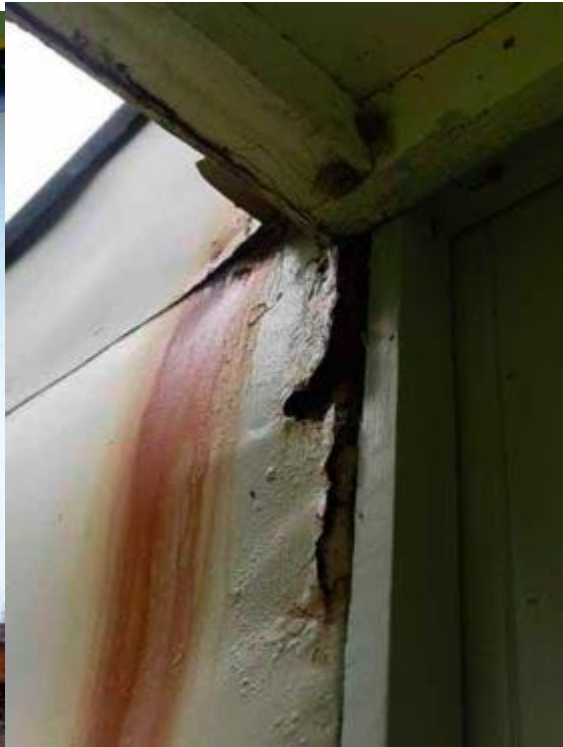
Hugh investigating behind rusting flatiron. May, 2016.

Below, rusting wall flatiron. May, 2016.

The external wall beside the door had rust holes all the way up it, leaving the stud and inside exposed. We took the sheet off and replaced it with new coloursteel flat iron we had taken in for the job. We will use sealant on this next time we are there. Our sealant tubes, both of them new, were partially set, and impractical to use. However there should be no problem for the next few months.

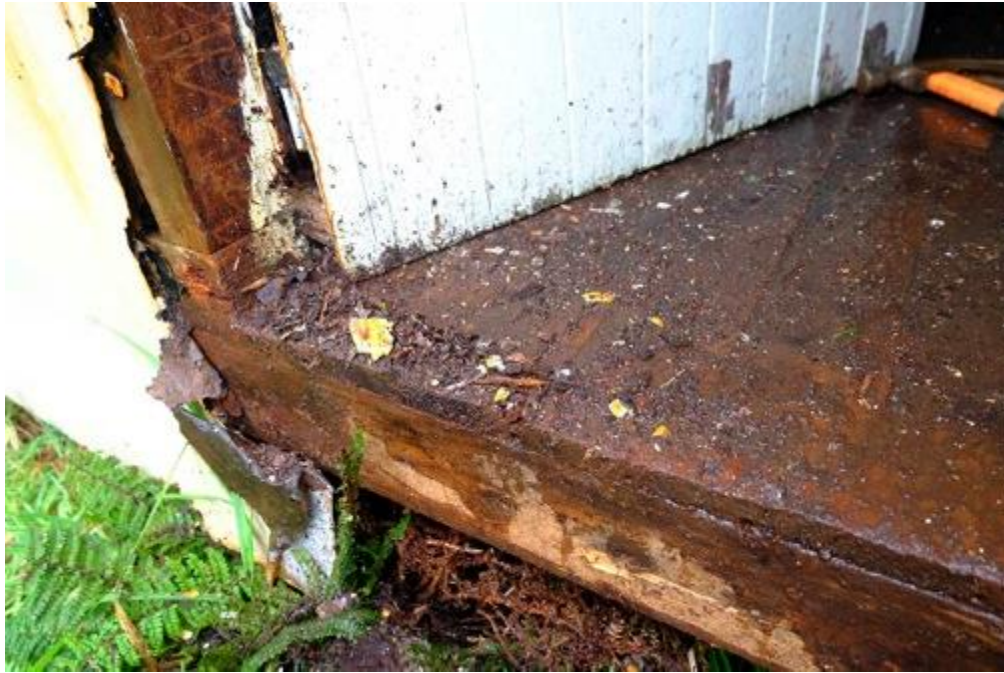
Door entrance, May 2016.

The door design ensured that water ran onto the tin plate sill, and then inside. We added a sloping wooden strip across the bottom of the door and now water will shed to drip beyond the floor edge. I will add some sealant to that when I return in spring/summer to paint.

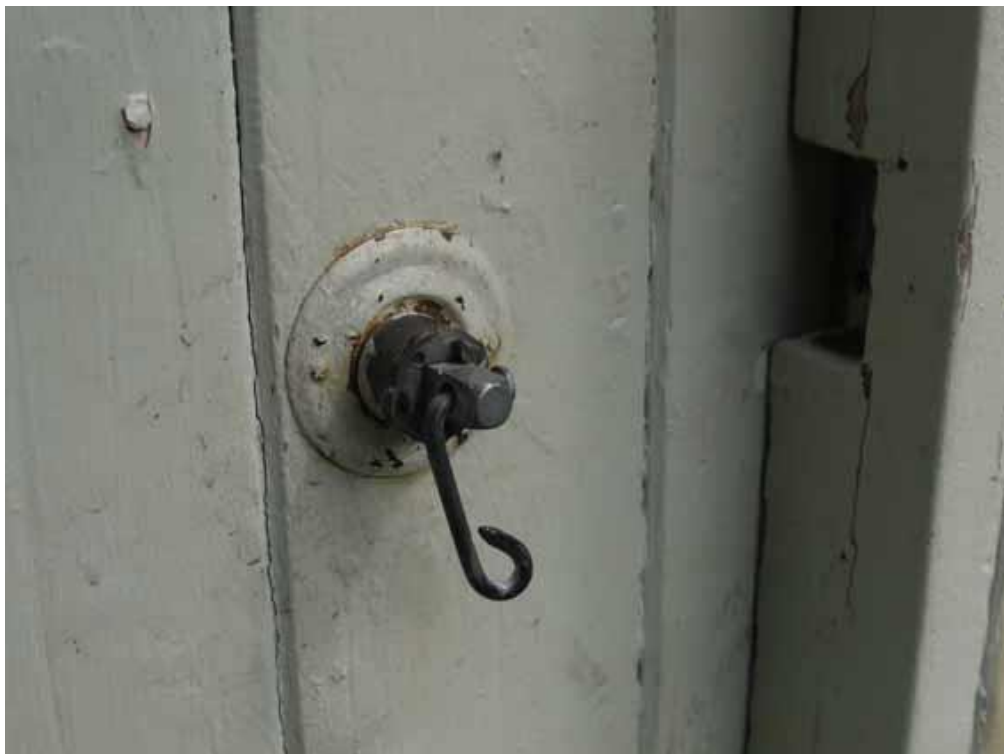
Door handle, May, 2016.

The door latch was rusting and in poor repair. We replaced that.

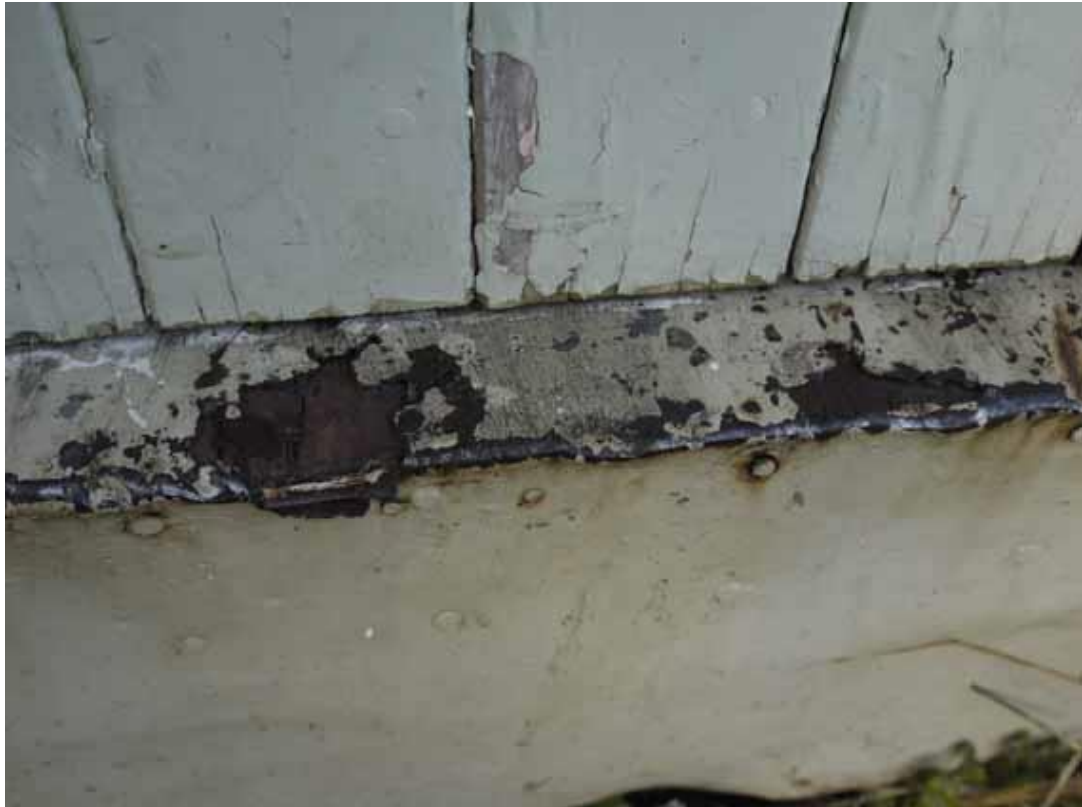
Rusted out door sill, May 2016.

The door sill flatiron flashing was rusted out badly in places on the floor lip. We replaced it with new coloursteel flatiron.

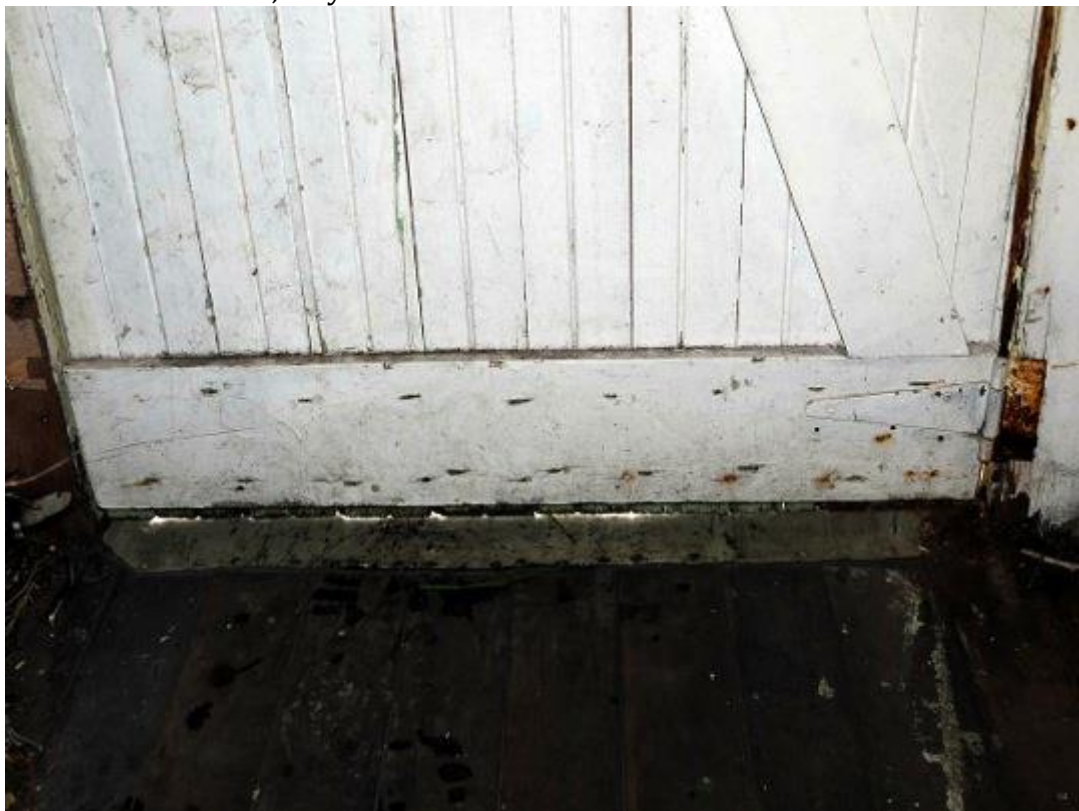
Rusted door hinges, May 2016.

The hinges were also rusting, particularly the bottom one, which collapsed as we removed it. We replaced all three.

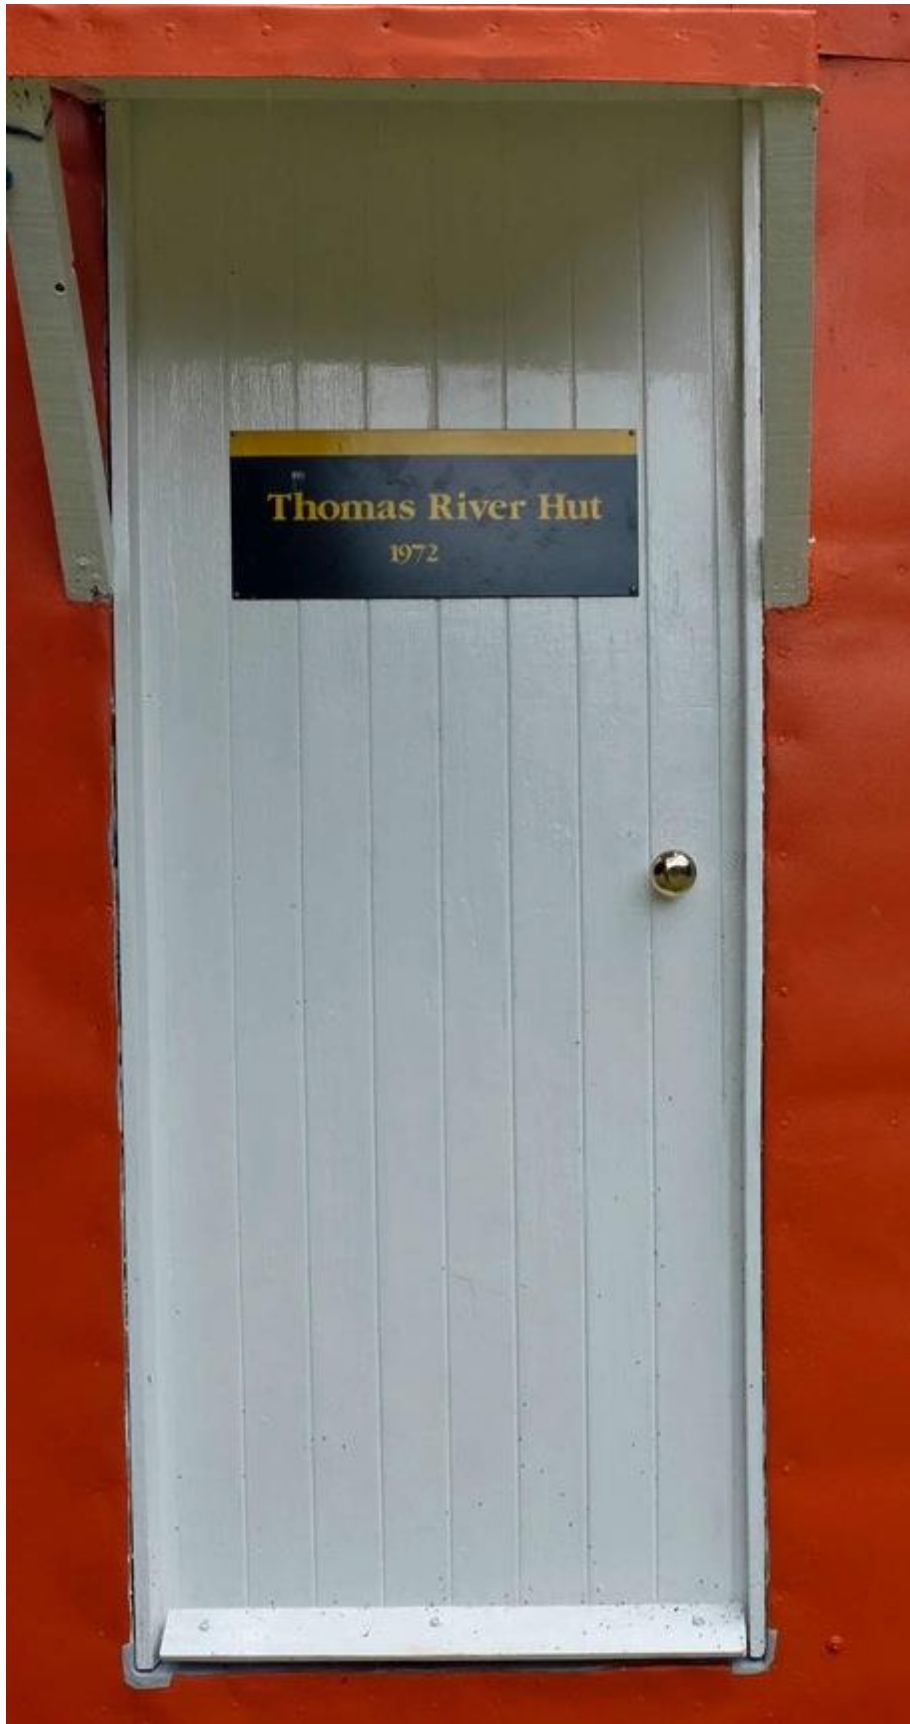
Door, Nov 2016. New doorhandle and latch, doorsills, flashing and paint. Needs final touchup still.

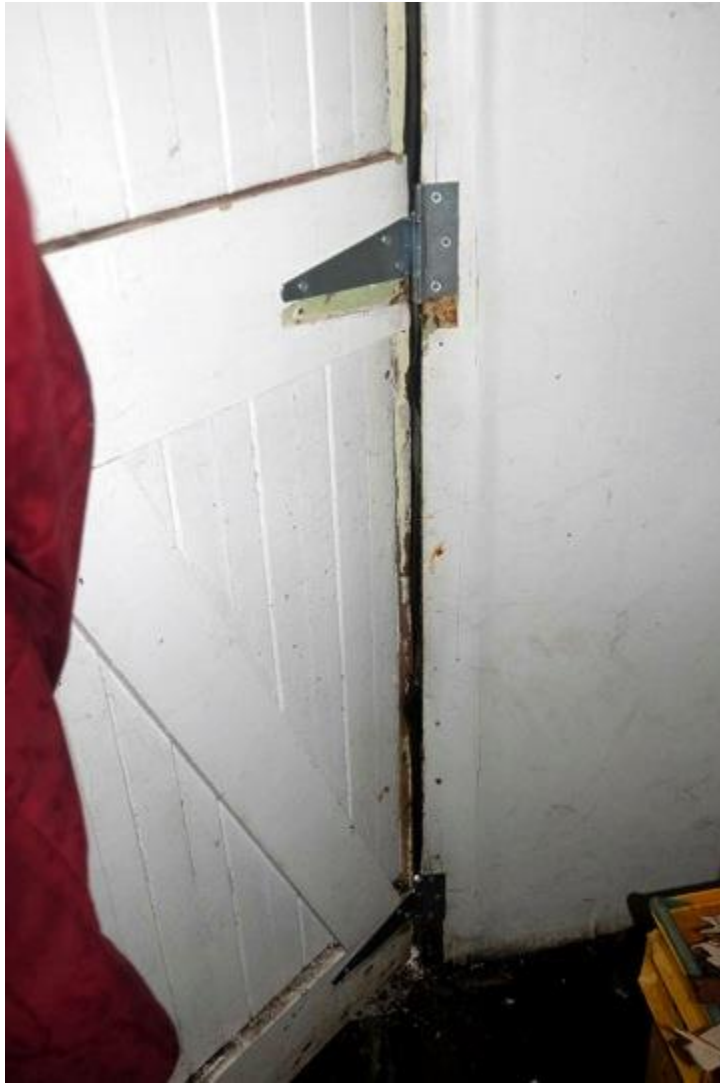
New Hinges, May 2016.

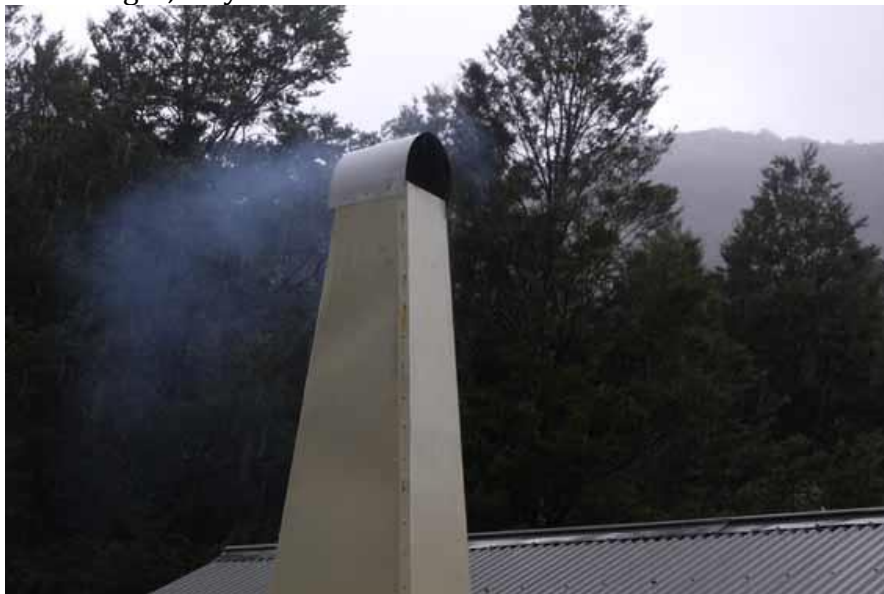
New Cowling, May 2016.

Using bolts, we added a curved cowling to the chimney to stop rain pouring down it. Works well.

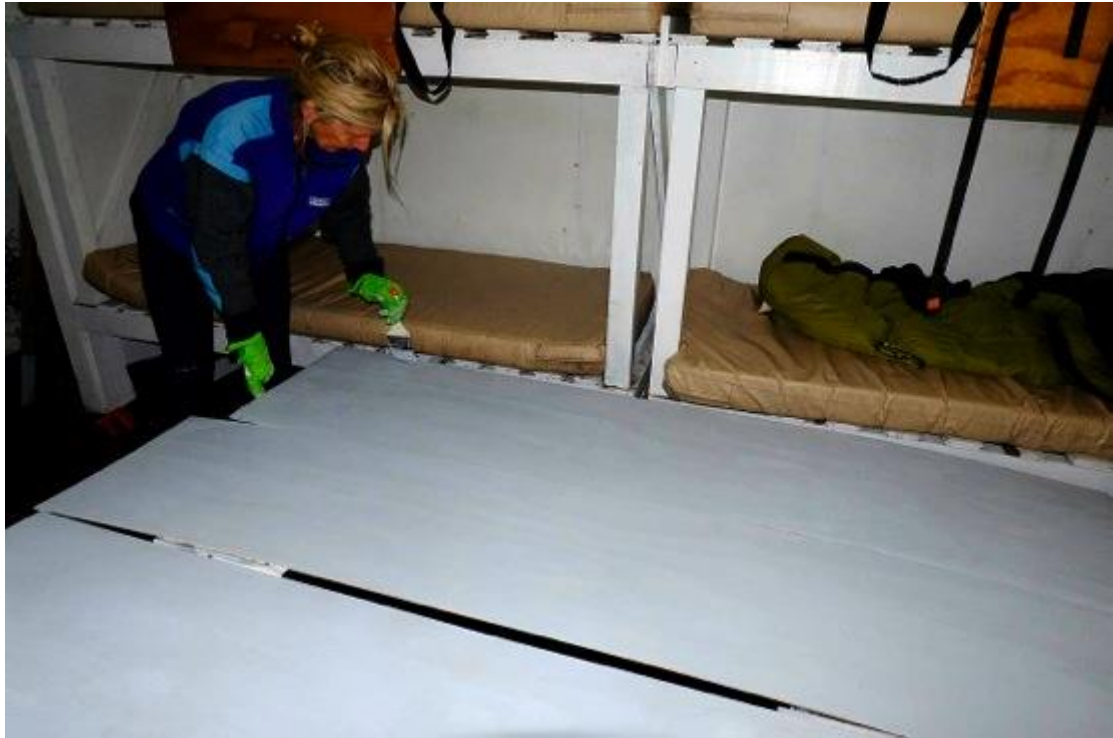
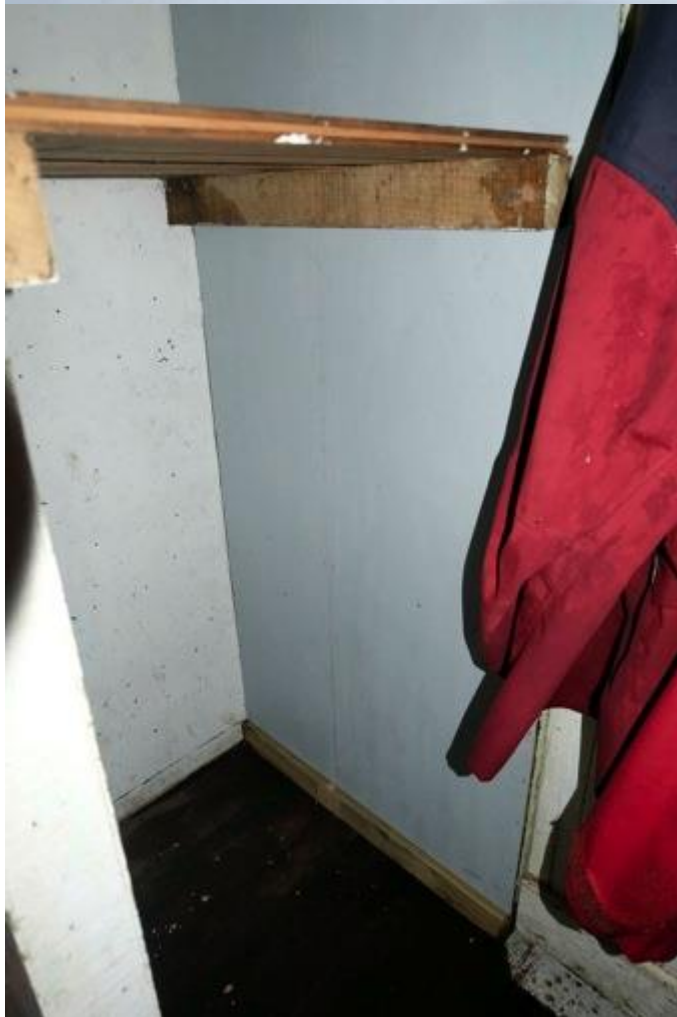
Liz undercoating new ply.
Replacing delaminated ply in the porch. May 2016.

In the vestibule just inside the door we replaced ply sheets that were badly delaminated.

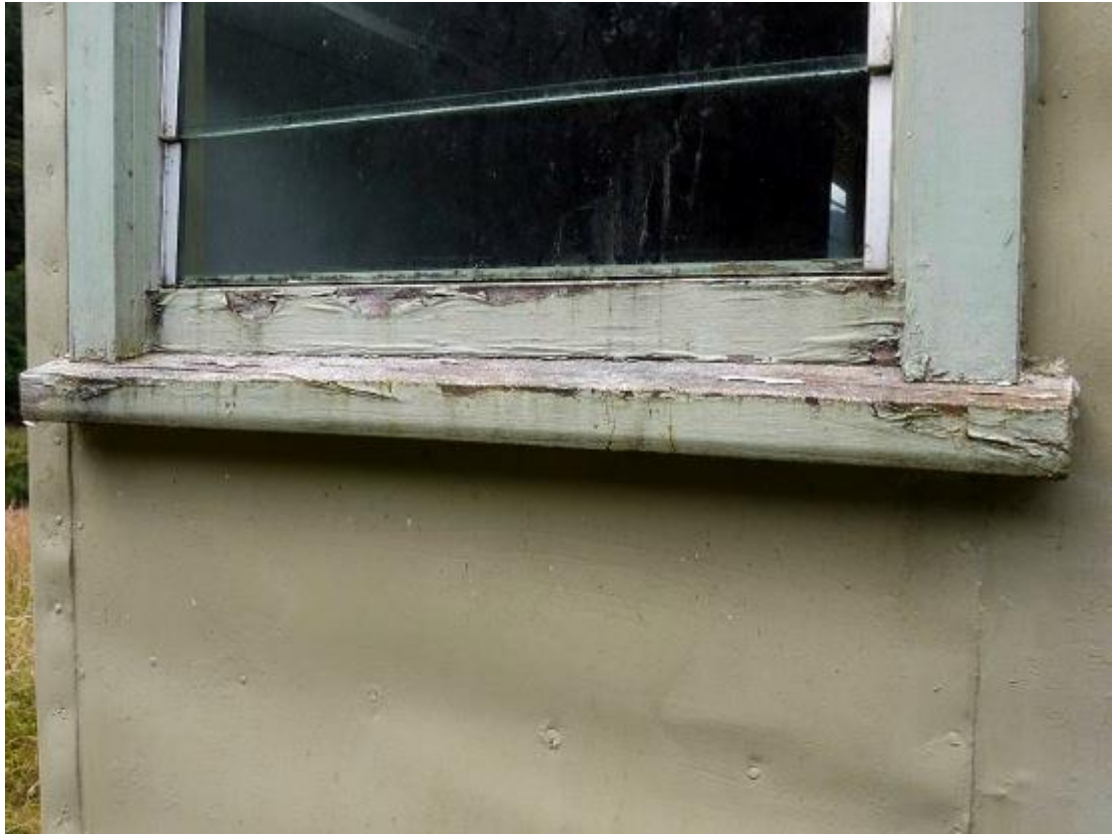
End windowsill, Feb 2015.

Wet areas under the end window indicated that it was leaking. We took the whole windowbox out and cleaned, scraped, sanded and primed the window up properly, before completely reflashing the sill and edges before reinstalling it.

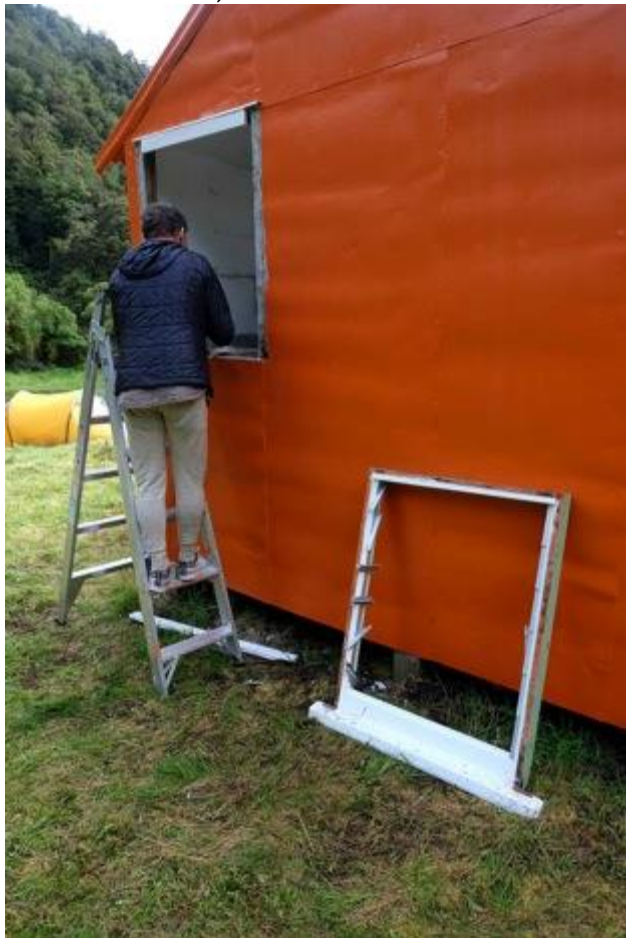
Peter with the end window out to reflash it.

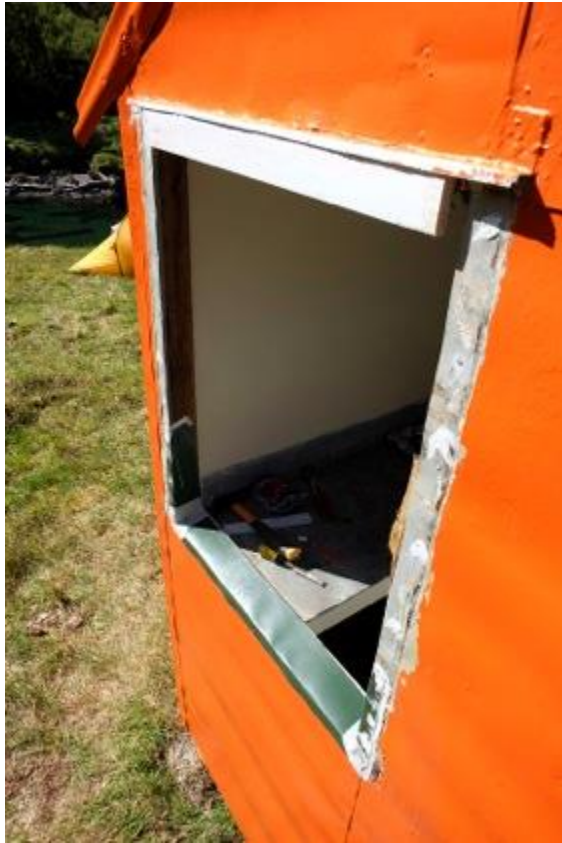
Reflashing the end window.

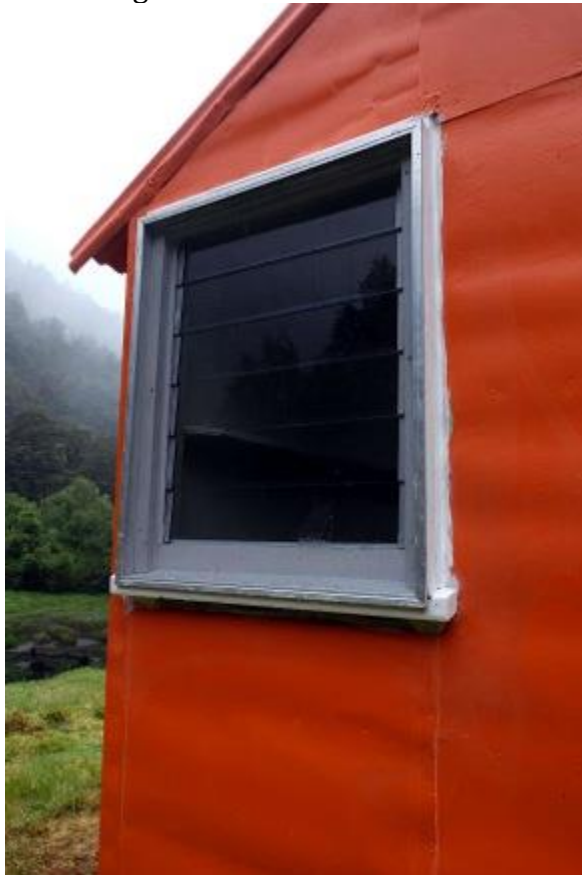
End window cleaned, reflashed and painted with flyscreen. Nov 2016.

Added a flyscreen to this end window.

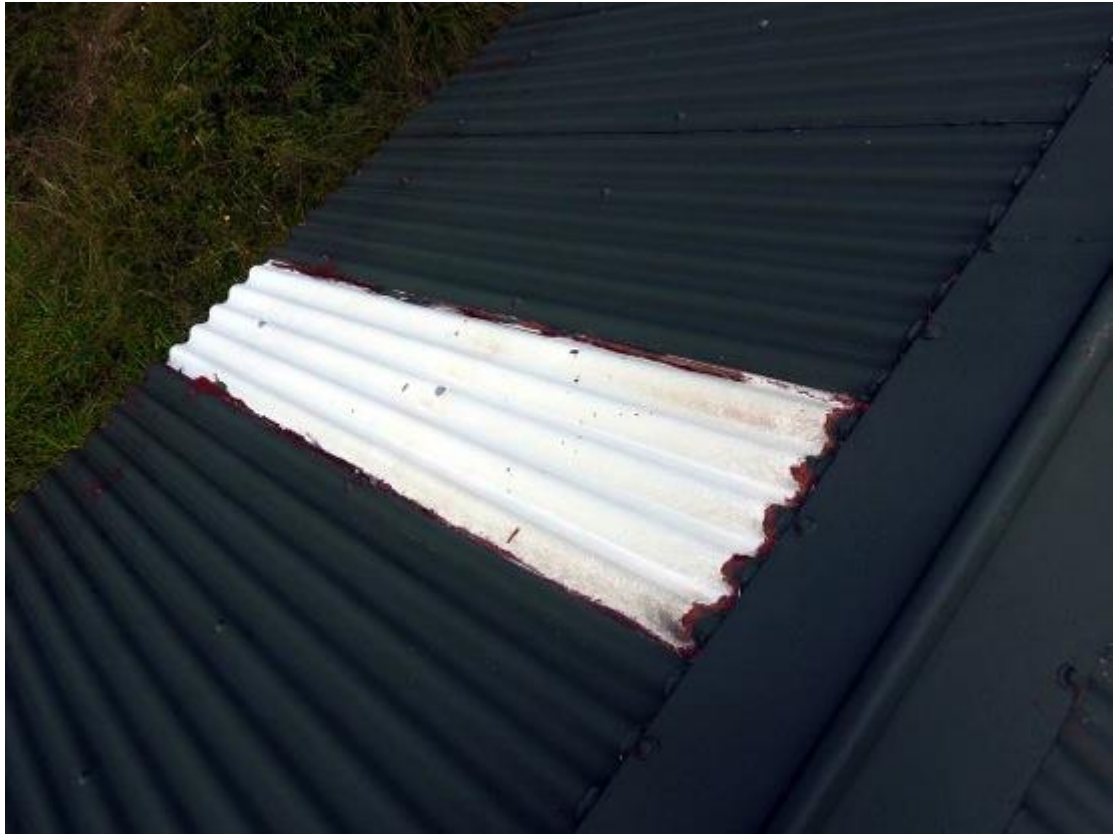
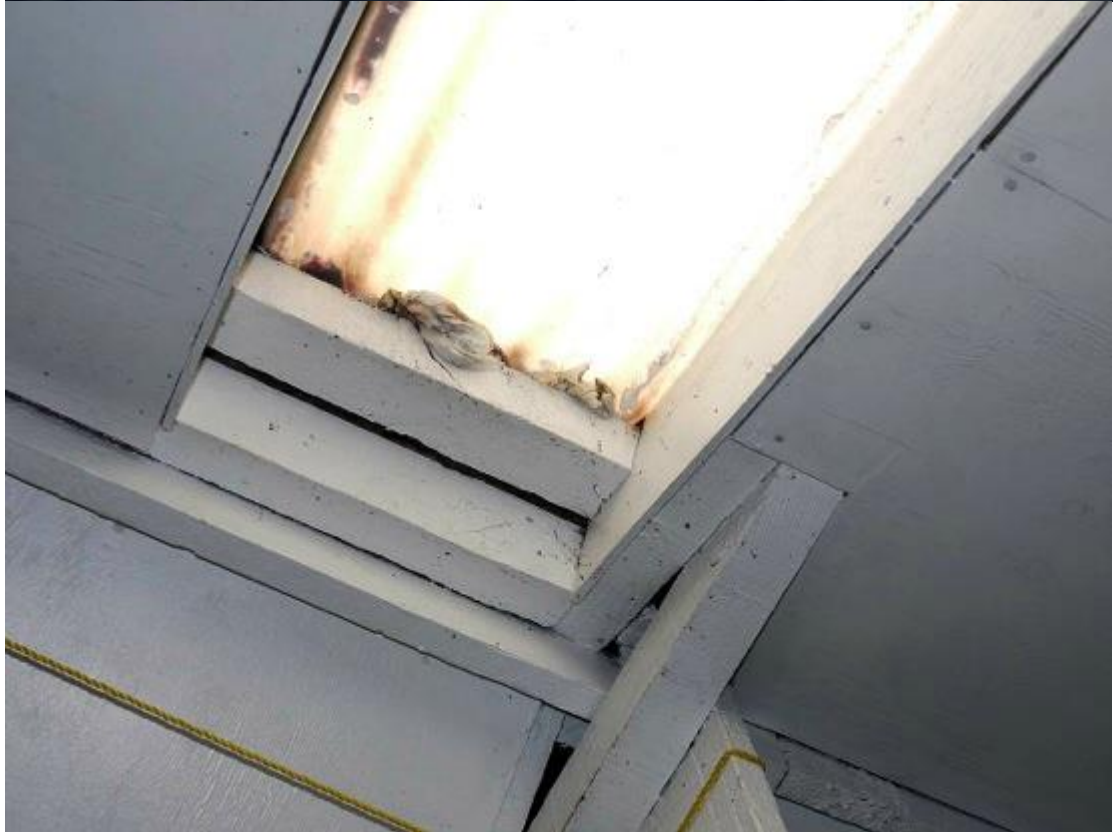
Old skylight, inside and out. 2015.

Replaced the skylight and underlined it with clear PVU sheeting, which is UV resistant and used for the likes of windows in caravan awnings. Increased the width of the skylight while keeping normal roof laps each side. This meant reboxing up around the rafters, but no rafters affected of course. Added foam at top and bottom of the skylight.

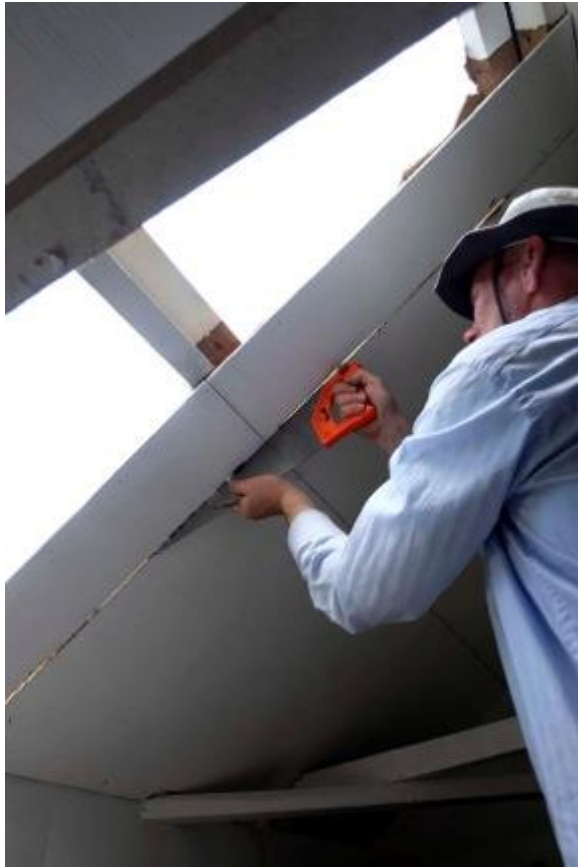
Hugh trimming ply to new dimensions for the skylight. Nov 2016.

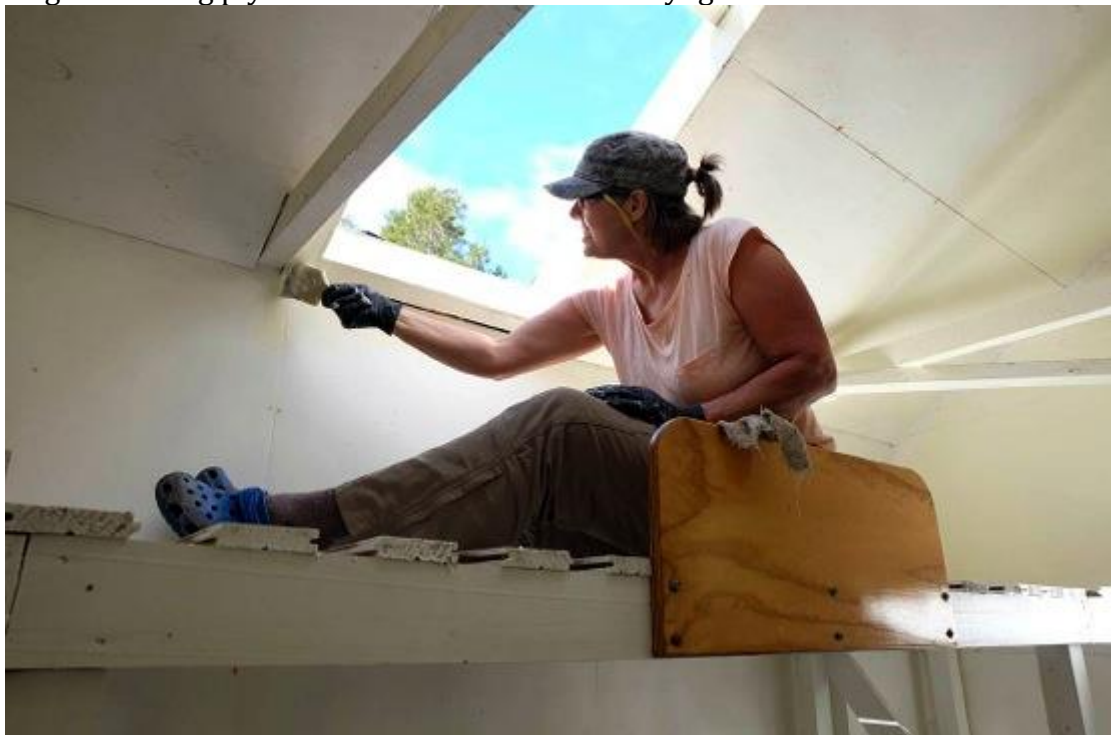
Tracy Lee painting the skylight windowbox, Nov 2016.

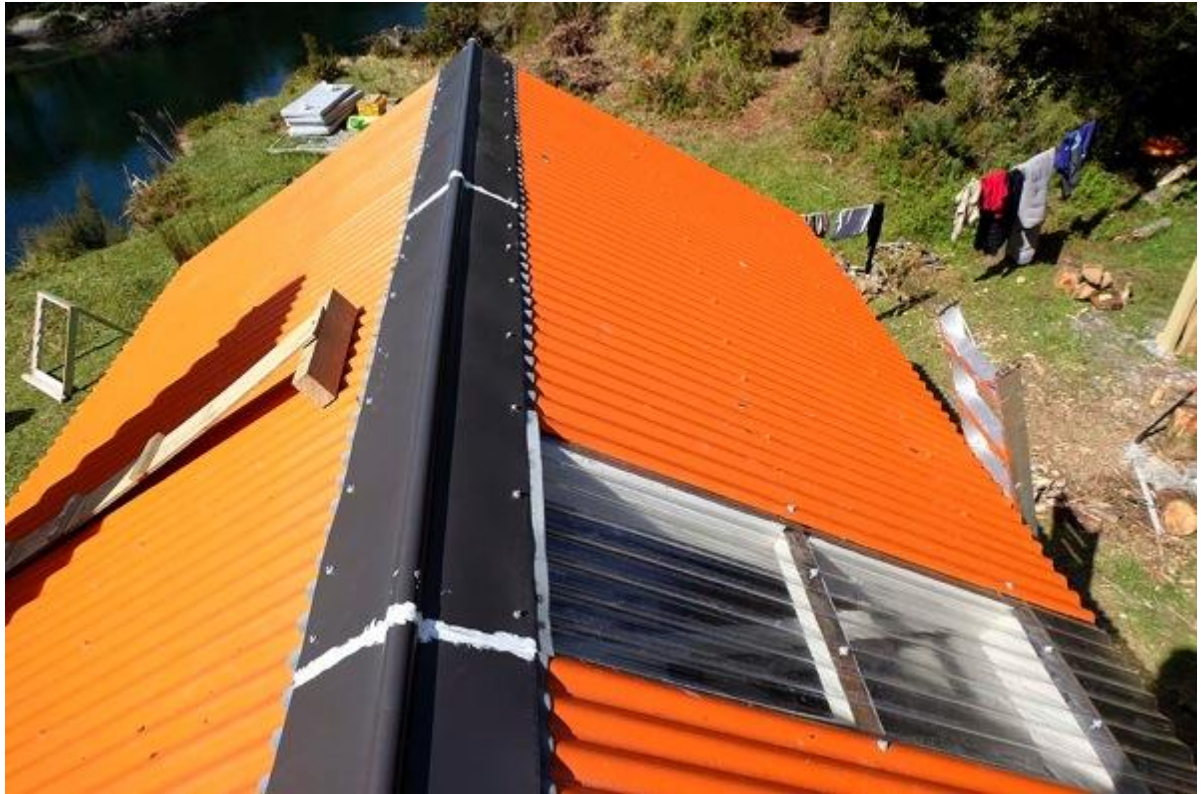
New skylight in and new wide ridging on the roof. Nov 2016.

Replaced the ridging on the roof. The ridging (and roofing iron) are still in reasonable nick. However, the ridging has soft lead flashing all along the edges, so this has all been covered over with new wide ridging so it is now kea proof. This is attached with tech screws. We replaced leadheads with tech screws in other parts of the roof as well.

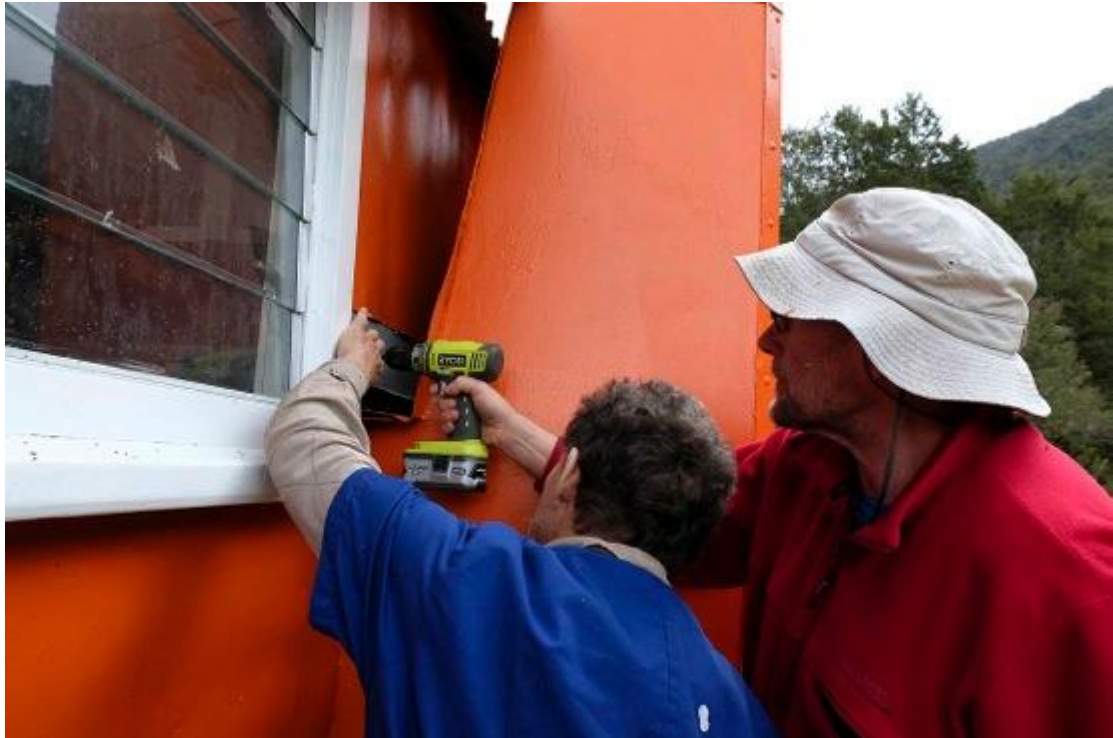
Peter and Hugh adding a strip of flashing to weatherproof the chimney wall. 2016.

We put in a piece of new coloursteel flatiron flashing behind the chimney where a rudimentary flashing had been put in years ago, but wasn't long enough to do the job, leaving a section unflashed out of sight. Tech screwed it in place and now all covered.

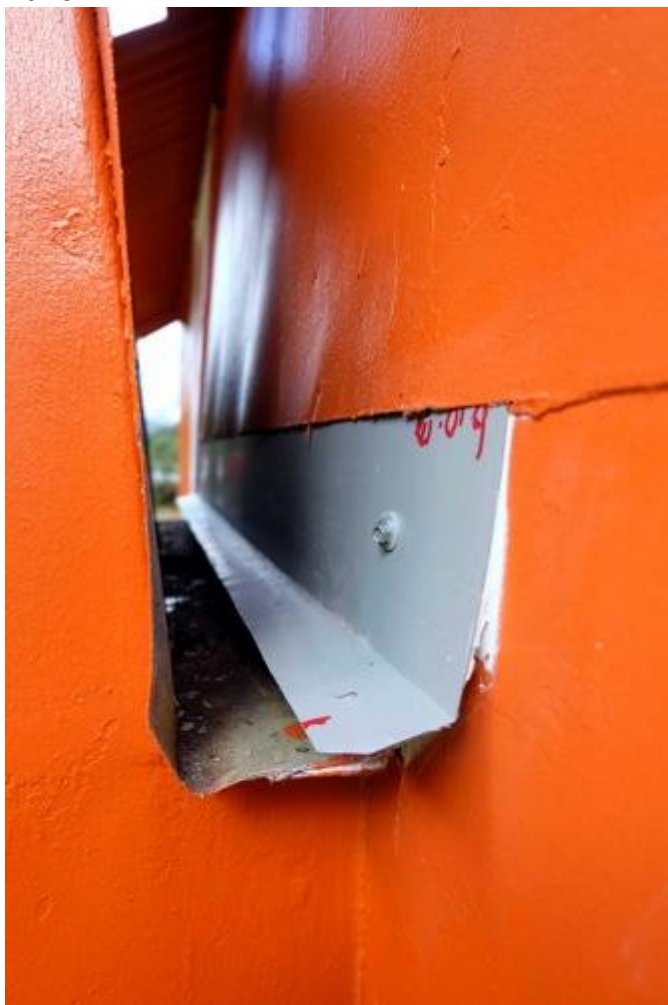
New coloursteel strip to flash the chimney wall properly. Nov 2016.

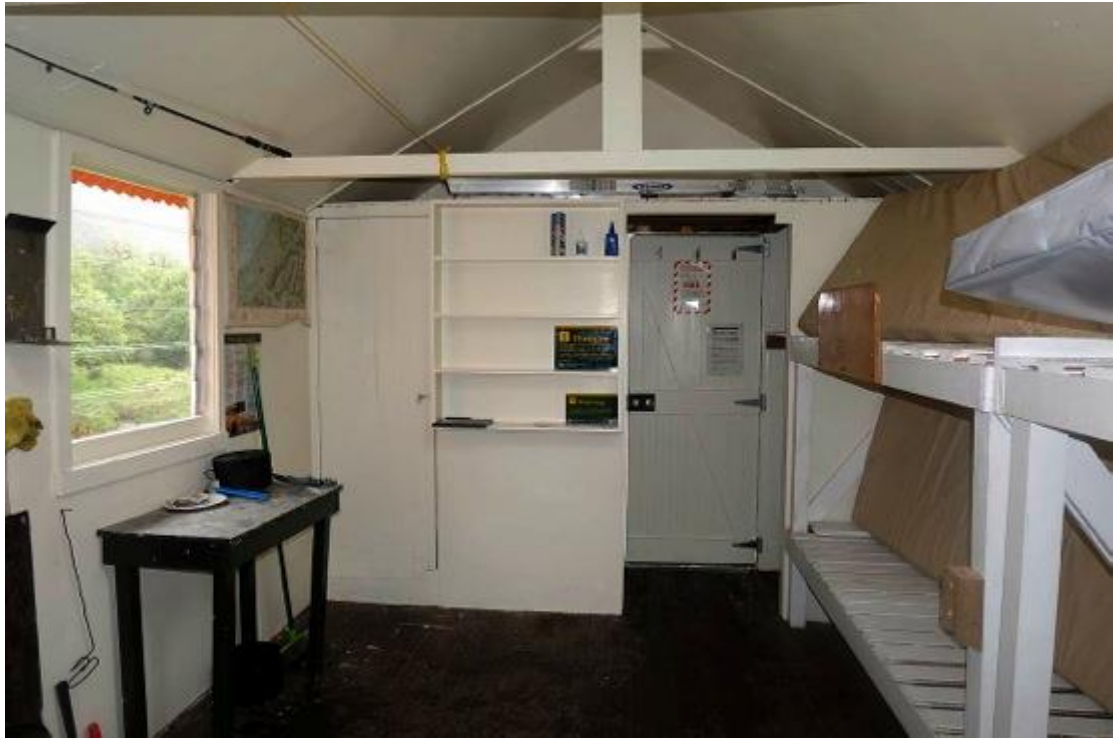
The hut interior after scrubbing, cleaning then painting with 2 coats. Nov 2016.

Inside the hut all the walls and ceiling were cleaned and scrubbed with sugar soap and then dried before painting with Dulux Wash and Wear Plus Kitchen and Bathroom semi gloss, Totaranui half. Two coats.

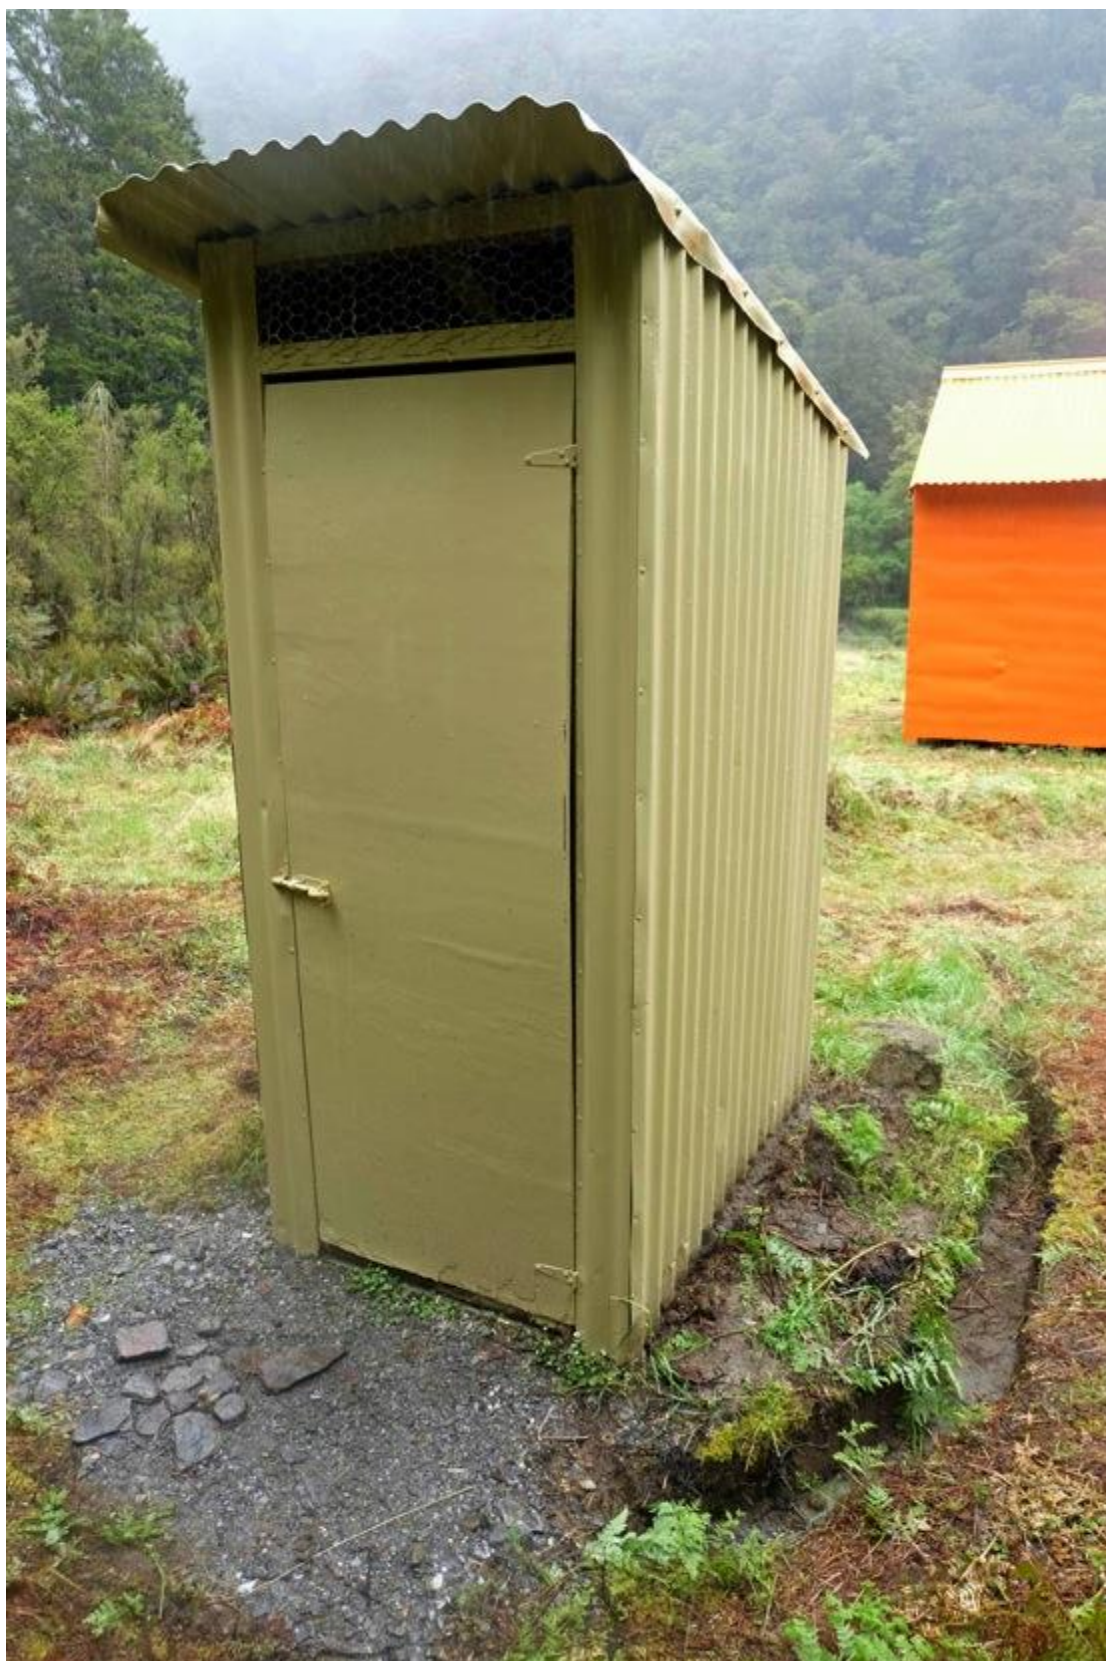
Toilet after painting. Nov 2016.

The toilet leaked badly in rain. We have proofed it by sealing holes in the roofing iron, and folded the edges down at roof level to stop water blowing through. We have also used flashing tape in a couple of places where water was blowing through. The toilet was then scrubbed down and sugar soaped before painting.
