THOMAS RIVER HUT REPORT

For DOC, the Consortium, and Permolat.

Geoff Spearpoint update 23.11.16

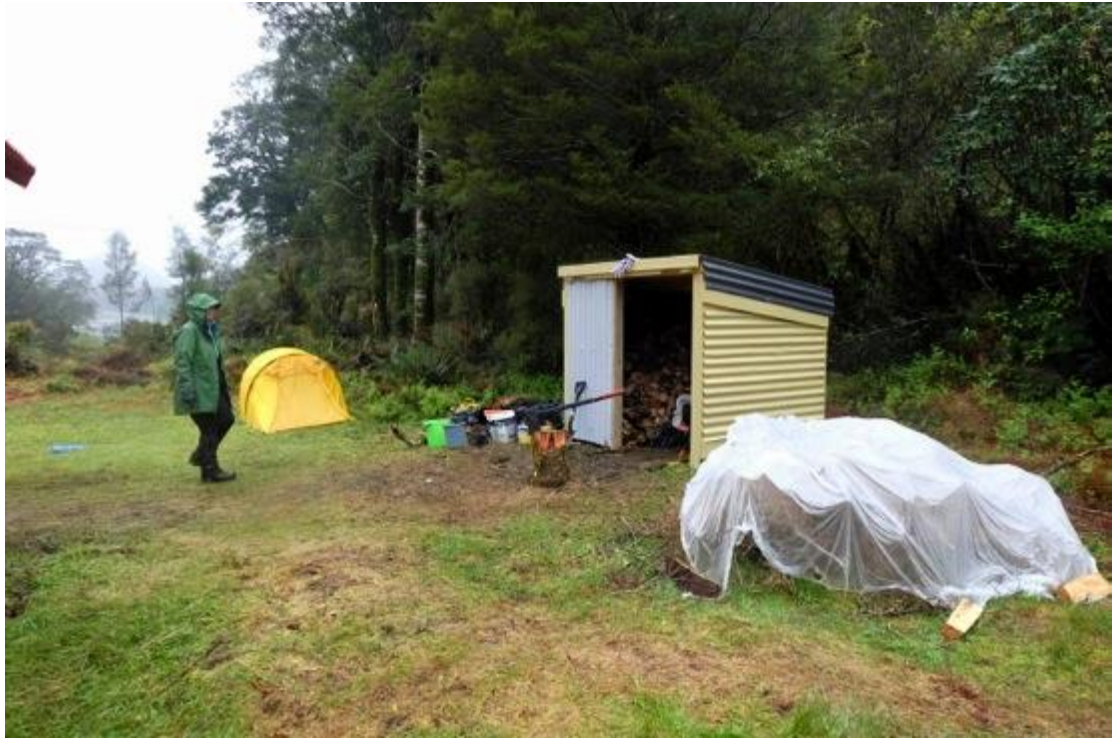
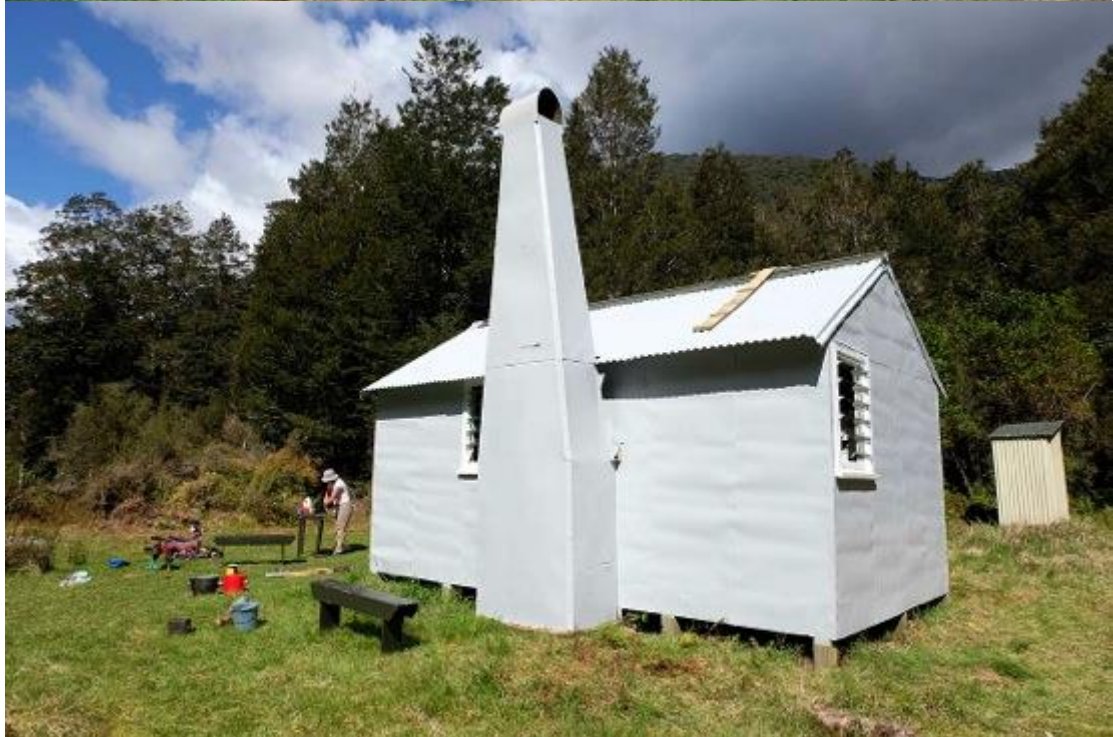
Top, the new woodshed, Nov 2016.
Below, after a coat of Quitarust Primer. Nov 2016.

We also built a new woodshed, using 50x100 timber and corrugated iron walls and coloursteel roof. The 100x75 posts are well cemented in. We gravelled the floor and entrance to it. Looks good and sharp. I went over it to make sure all tin corners were folded back so as not to catch anyone, and the design, with wood covering the corrugated iron ends in the front makes it well protected.

Added a bit more cover at the front of the woodshed to provide more protection from driving rain. It is neat and tidy.
